**Re: Recommendations for Historic Preservation Compliance, Lockwood Valley Ranch,
Unincorporated Ventura County, California**

ATTACHMENT A: Photographs of Reyes Adobe

ATTACHMENT B: Structural Engineers Report

RE: Reyes Adobe
Silman Project No 3026.0030145

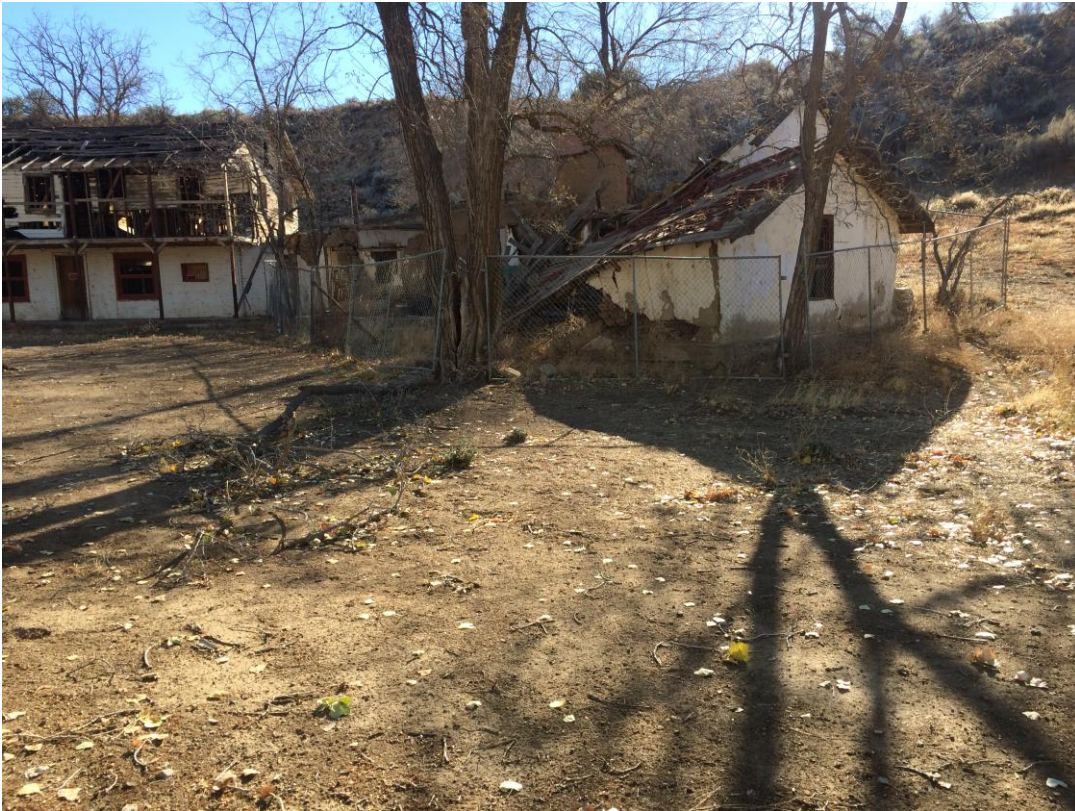
The Reyes Adobe is located in northern Ventura County on Lockwood Valley Road two miles east of Route 33. The main building consists of a two-room adobe constructed in 1854 with several alterations and additions made over the years, including a two-story addition on the south end (c. 1947) (Figure 8). Other buildings on the parcel include a smokehouse (1854) located approximately 15 feet west of the main building, a cabin (1956) (Figure 9) and a washroom (1947) (Figure 10).

Figure 8. Overview of adobe and addition looking southwest.

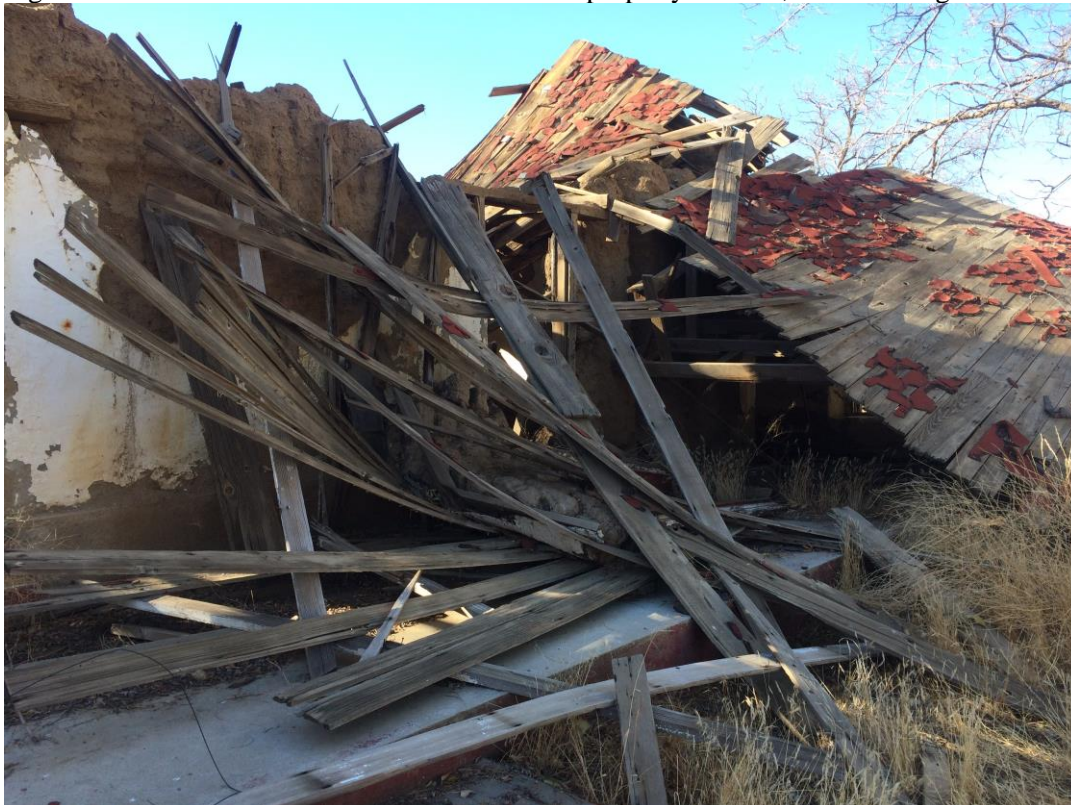
The condition of the adobe has been steadily deteriorating since 1972, with the assessor determining the building had no value in 2013 (Ventura County Assessor 2023). The roof has collapsed in most locations and several walls have fallen (Figure 11). The building has an irregular rectangular plan with a one-story rectangular section to the north containing the central original adobe surrounded by later additions. To the south is a two-story rectangular building abutting the earlier building and at one time connected by a porch.

Figure 11. View showing collapsed roof and walls of northern section of the original adobe.

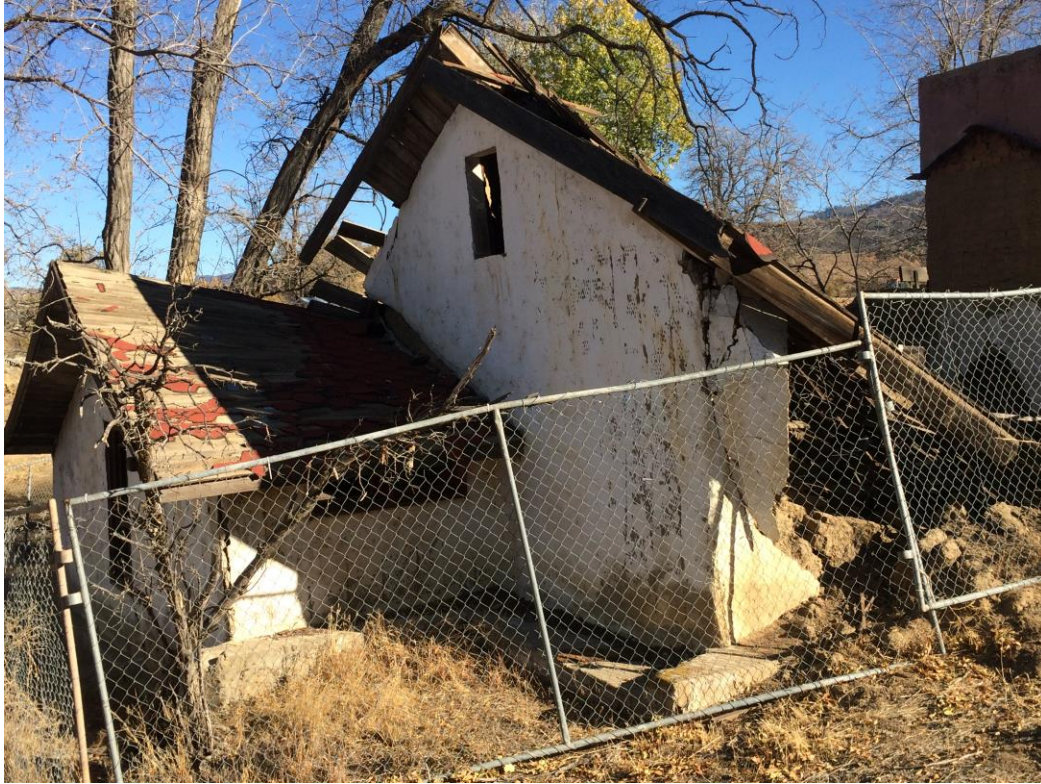
The adobe walls of the later additions to the north are still standing, indicating the original side gable shape of the roof (Figure 12). Portions of these walls have been covered with cement and have the only recognizable fenestration. A one-over-one sash window is located on the north façade and a clerestory window in the upper section of the west façade (Figure 13). Although the central portion of the adobe is mostly deteriorated, a chimney located in the middle of the original section is still extant (Figure 14). Because most of the walls have collapsed, it is difficult to determine the fenestration pattern in this central section. A door was located near the chimney on the east façade, with another on the south end near the two-story building. Historic photographs and assessor records indicate the building had a porch spanning the section from the north addition to the two-story building added in the 1940s (Figure 15).

Figure 12. Detail of addition walls which are still standing, looking southeast.

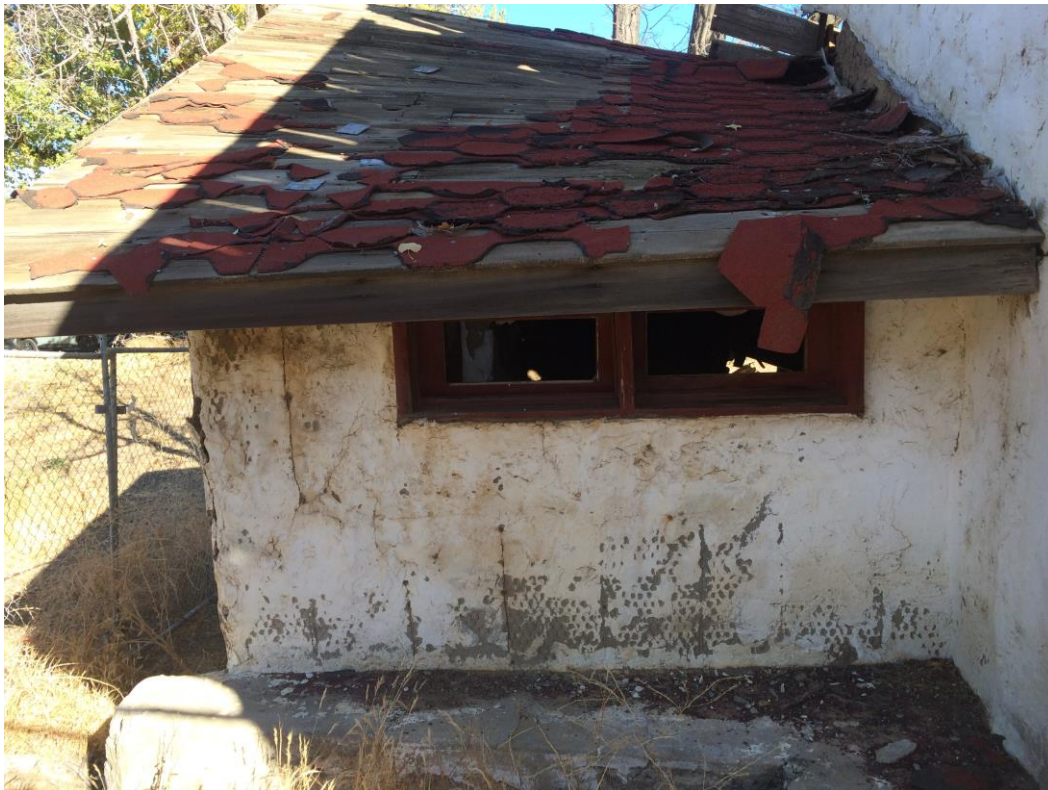
Figure 13. Detail of clerestory window on west façade of addition.

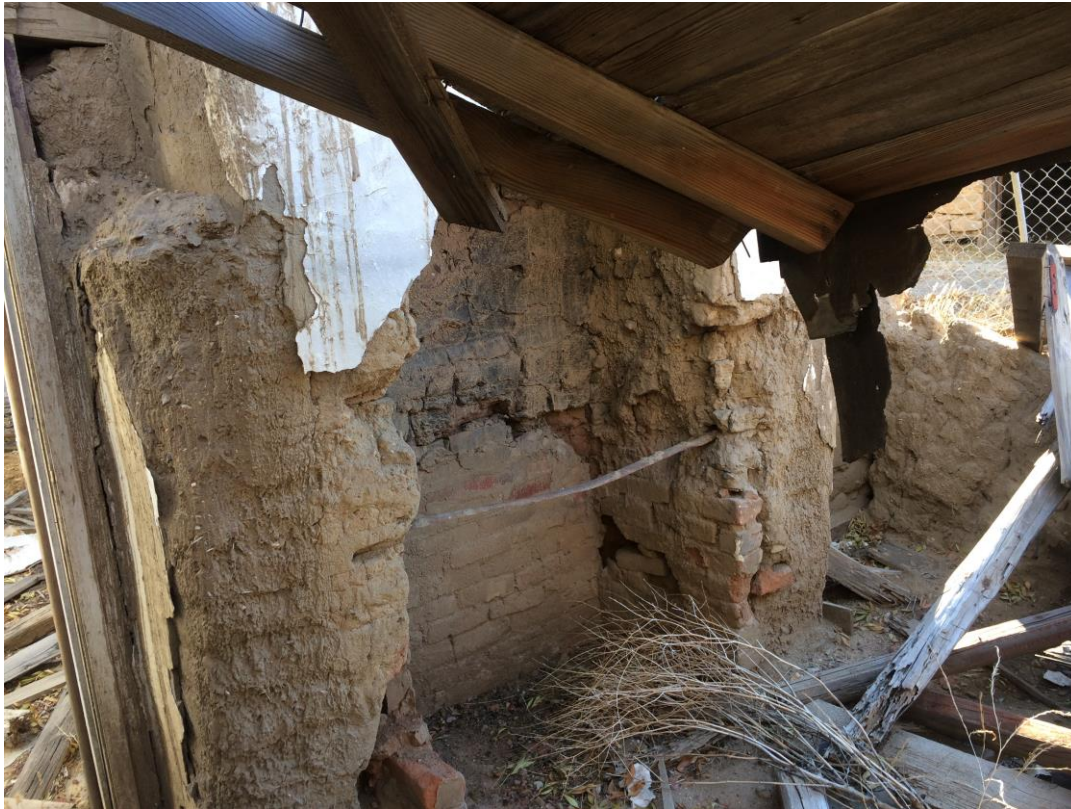
Figure 14. Detail of north side of original chimney.

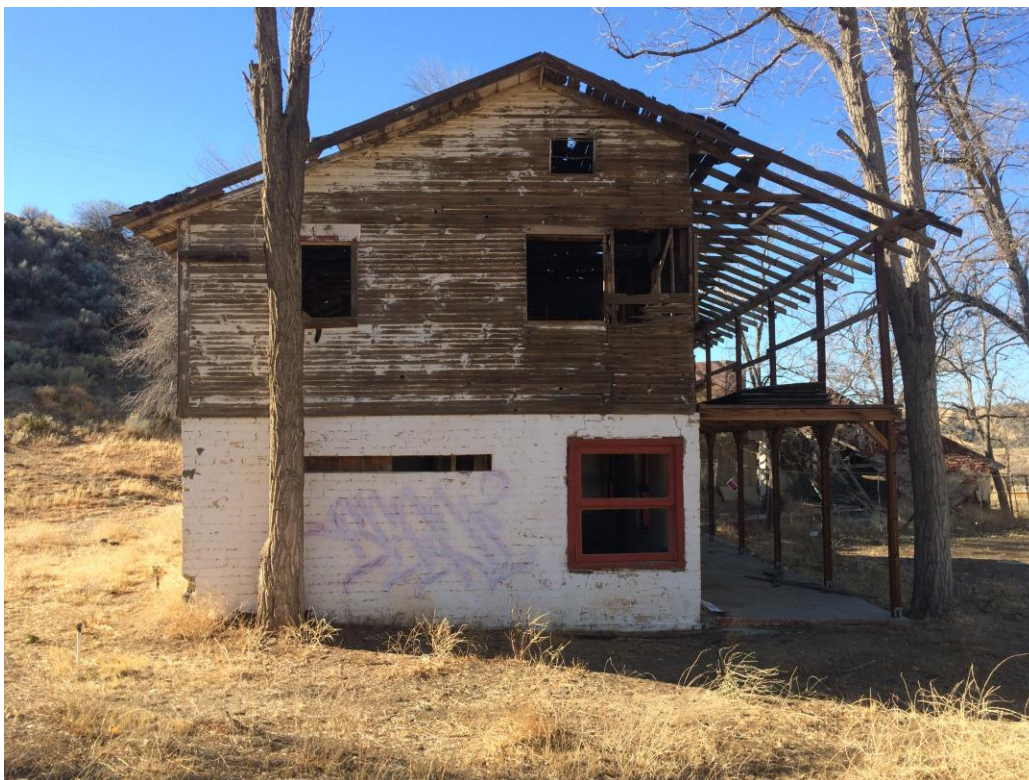
The south façade has a window matching those on the east façade at the east end of the first story, and a narrow window to the west which at one time contained glass block (Figure 17; see Figure 7). On the second story there were originally two square-shaped windows but only the openings remain. There was also a small window near the gable end. On the west façade, some openings have been covered with concrete, but there are still two openings on the north end of the first story (Figure 18). On the second story, the deteriorating clapboard makes the fenestration pattern unclear, but one frame is located near the south corner with two additional openings to the north. A portion of the second story overhangs the first at the northwest corner and there is a door located on the angled wall below near the junction with the one-story building. The second story of the north façade has two square openings with an additional window in the gable end (Figure 19).

Figure 17. View of south façade of two-story addition looking west.

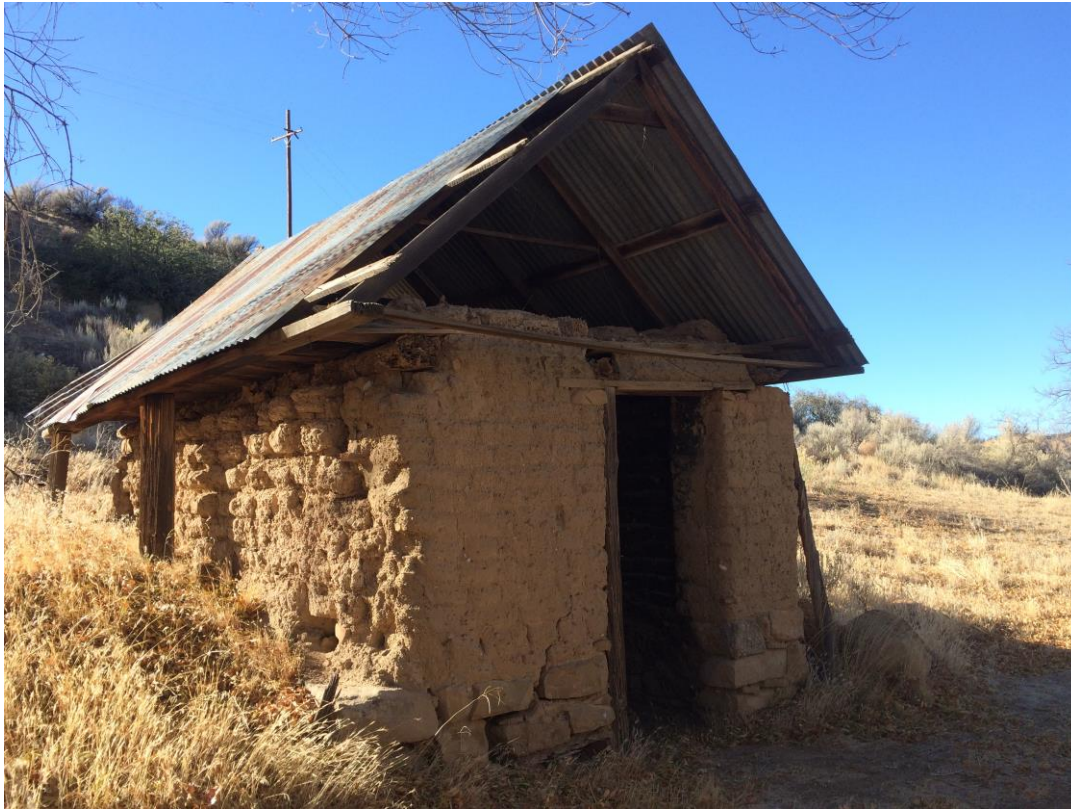
The smokehouse has a simple, rectangular plan with adobe walls and a wood-frame front-facing gable roof clad in corrugated metal (Figure 20). A wood framed door opening is located on the east façade. There is no other fenestration except for a small opening in the upper portion of the west façade (Figure 21).

Figure 20. East façade of smokehouse, view to the northwest.

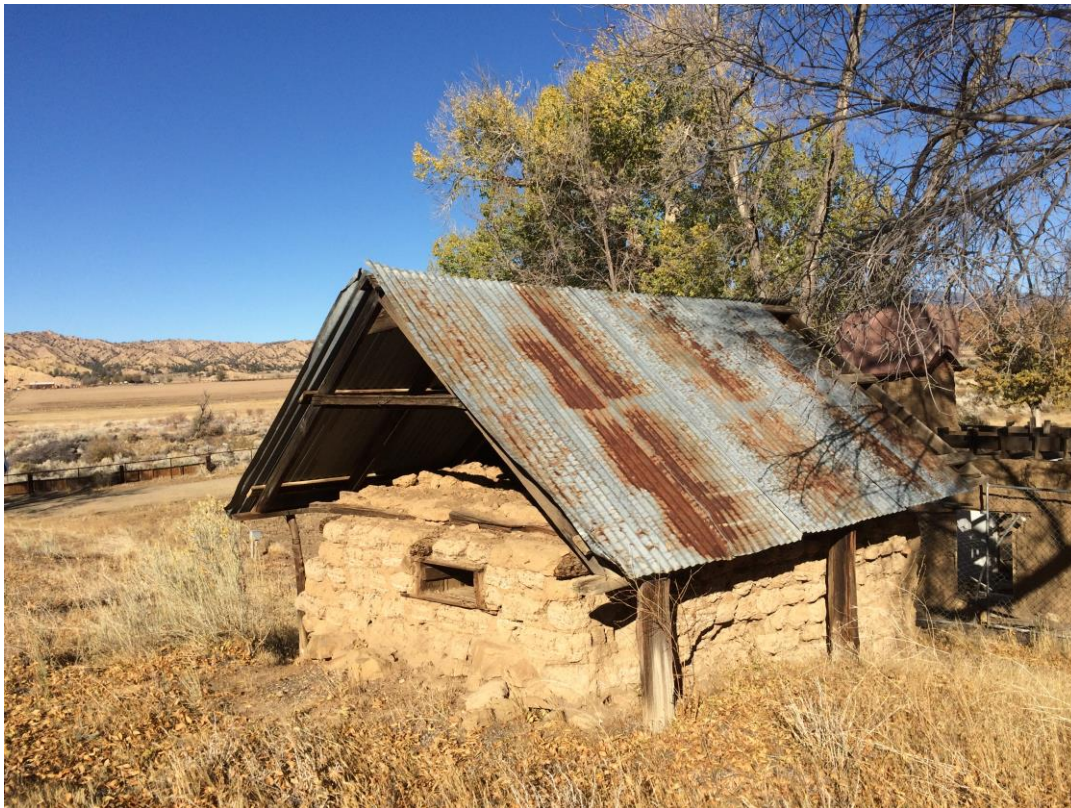
Figure 21. West façade of smokehouse, view to the northeast.

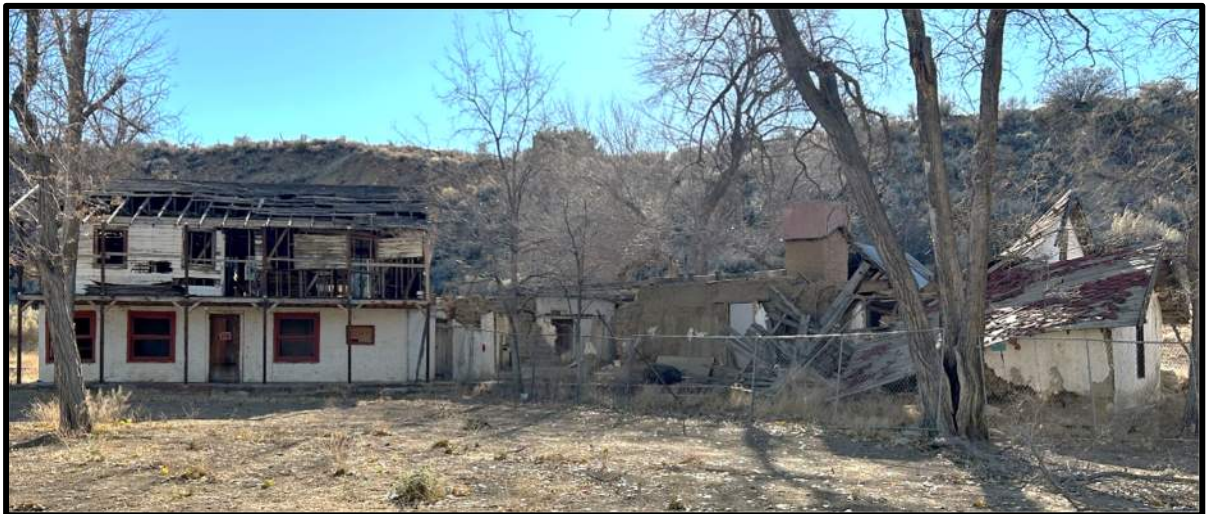
Site Photo of 1940s Addition (left) and Collapsing Adobe Buildings (right)

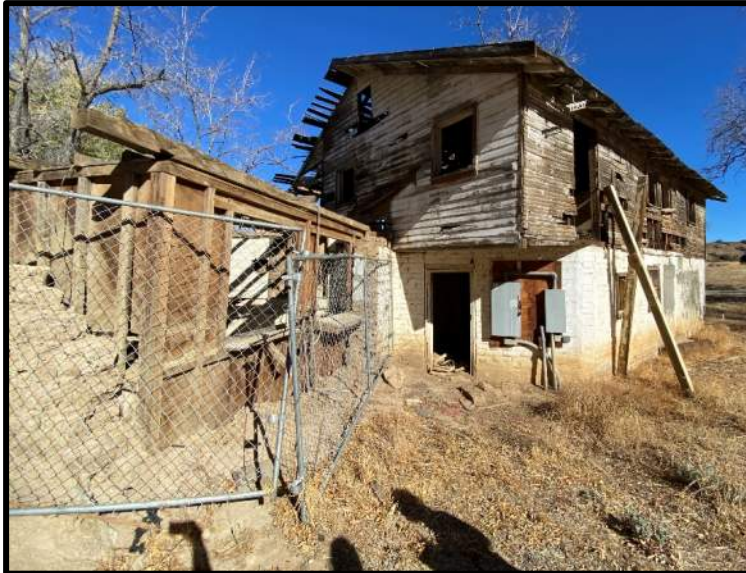
Fencing has been erected around the adobe building to restrict access as the site represents a significant safety hazard in its current condition.

Fence Restricting Access at Adobe Wing (left) of the Building

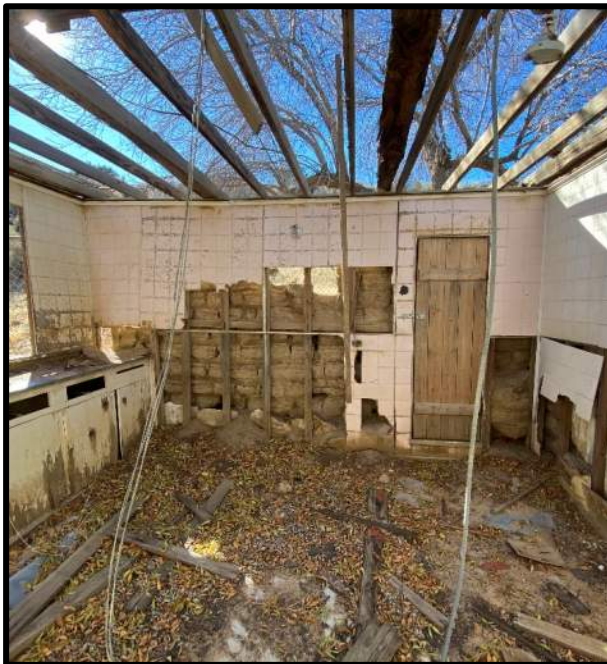
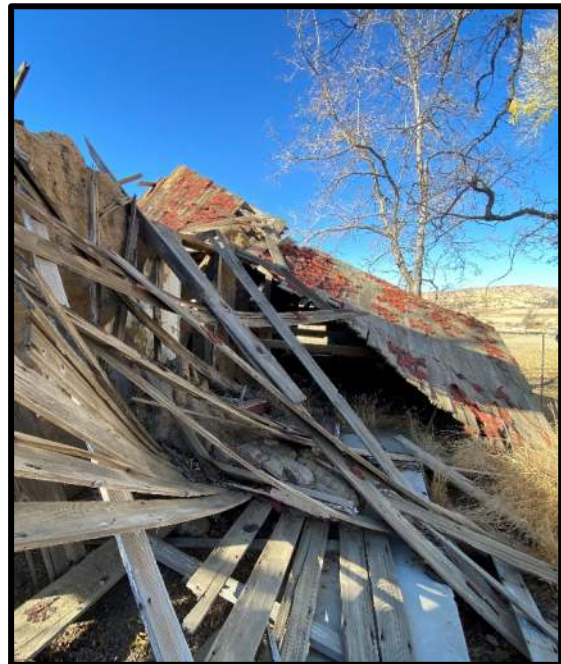
The roof over the adobe building has completely collapsed. At the south end only a few ceiling joists remain. At the north end the collapse appears to have been more recent and so much of the wood framing still exists on site and complicates access inside the two northern most rooms. In both cases the walls are free-standing from a structural perspective, which has further compromised their stability and in particular their performance in any future seismic event.

Remnants of Ceiling Framing at South End of Adobe (left) and Collapsed Roof at North End (right)

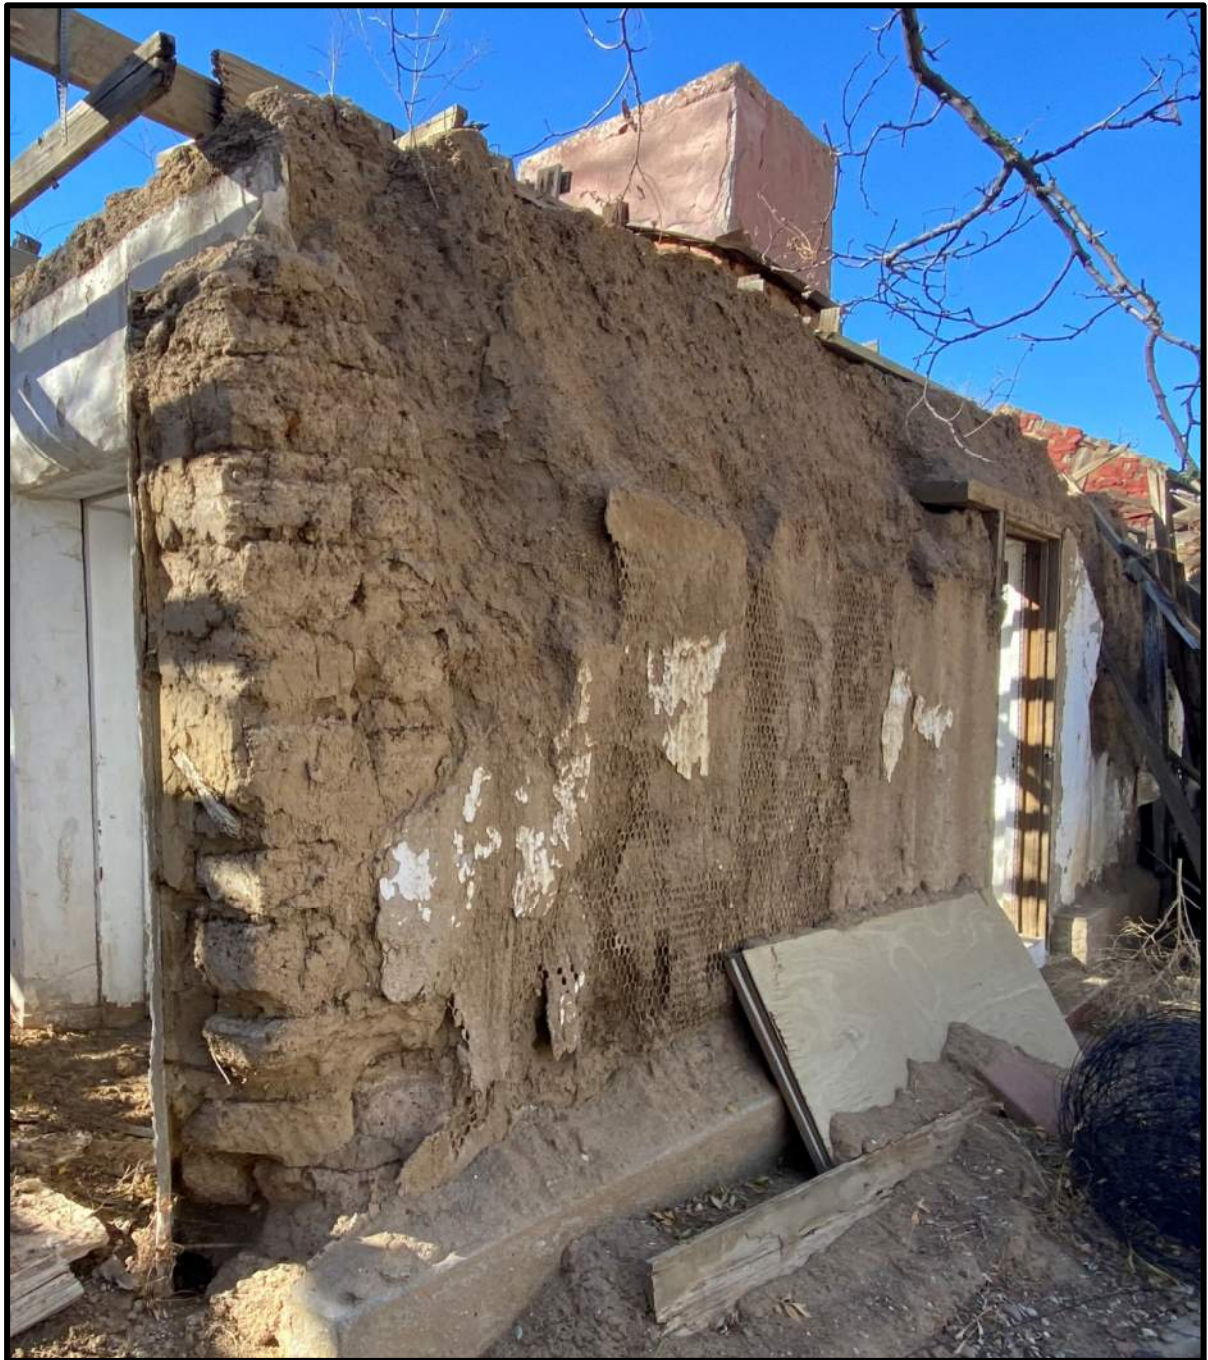
About fifty percent of the adobe walls have collapsed and are no longer standing. Where wall segments do remain, there are still localized missing areas, and many of the individual adobe blocks are no longer distinguishable as they have started to disintegrate (or 'melt') back into sand and clay. The deterioration of the adobe is due to prolonged exposure to the elements, and in particular water without protection from a roof.

Disintegration of Adobe at Original 1850s Structure

The original adobe and the later additions to the north and south are all in poor condition. Only about 50% of the adobe walls remain, and even where it is still standing the historic fabric is so badly deteriorated that it would need to be replaced with new adobe blocks. Below is a description of a few different options for the adobe moving forward:

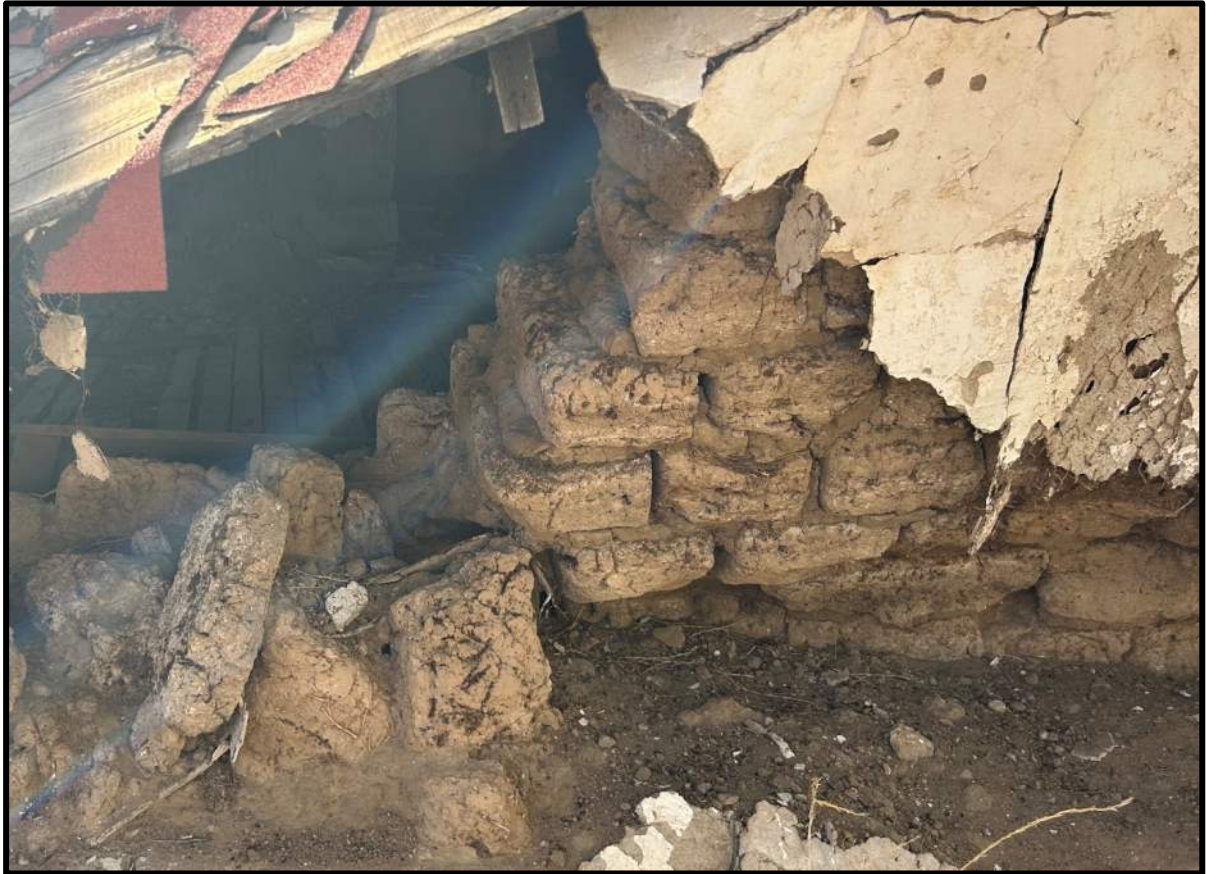
The adobe bricks in the later additions do appear to have kept a bit more of their shape. While the walls overall are not in better condition there are portions where you can still make out the joints and individual units. Where the adobe is exposed at the original structure the walls typically appear more as piled dirt without much definition of the individual blocks that once made up the wall.

Adobe Blocks at One of the Later Additions

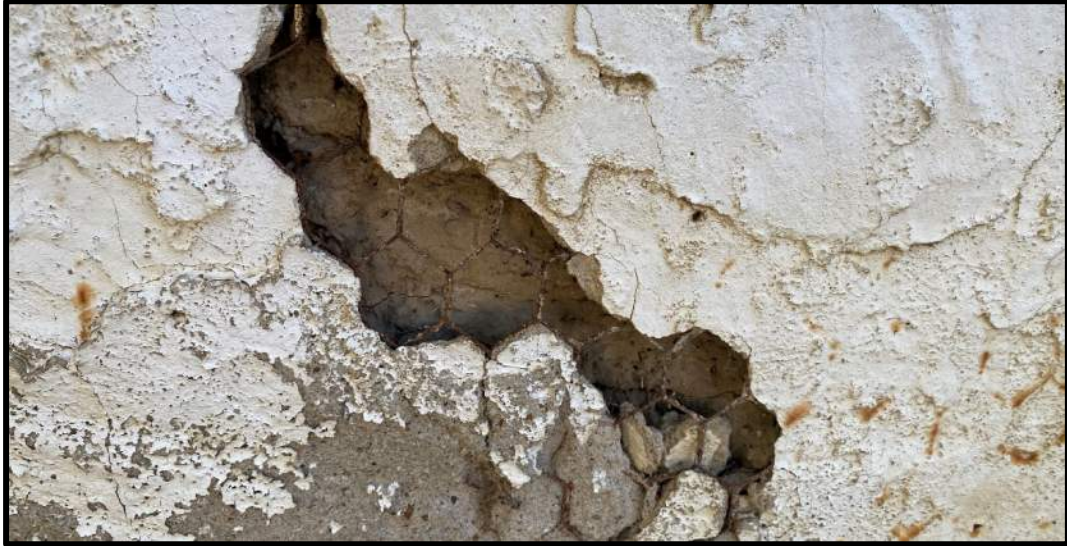
At some point in recent years the walls that did remain were covered with a metal lath and Portland cement-based parge coat. While the intent may have been to mimic an historic whitewashed plaster appearance it was an inappropriate repair which has significantly accelerated the deterioration of the walls. The tops of the walls are typically open and with the parge coat in place it limits how much the adobe can dry out and 'breathe'. This increased exposure to moisture and freeze-thaw cycling started to tear apart the wall. As the parge coat is a much stronger material the adobe is the weak link that starts to deteriorate. This damage is evident at a few locations where the parge coat remains but the wall behind it is completely gone. Even some of the wall segments that appear to be in fair condition are

really just the parge coat hiding the true condition of the adobe. When the parge is removed the adobe is likely to start to crumble.

Parge Coat & Metal Lath Over Adobe

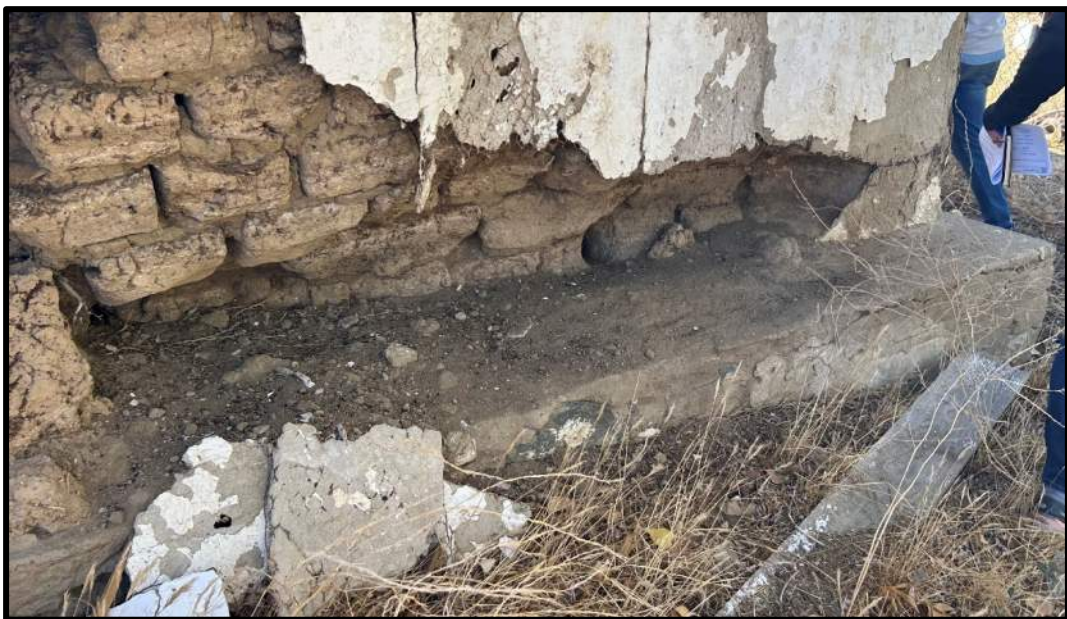
At portions of the adobe wall a past retrofit replaced the lower foot or so of the wall with concrete. Rising damp is when the adobe starts to wick up moisture from the soil, which can lead to accelerated deterioration at the base of the wall. This is likely why some portions of the lower wall were 'underpinned' in this manner as part of an earlier structural intervention.

Underpinning Replacing Lower Portion of Adobe Wall

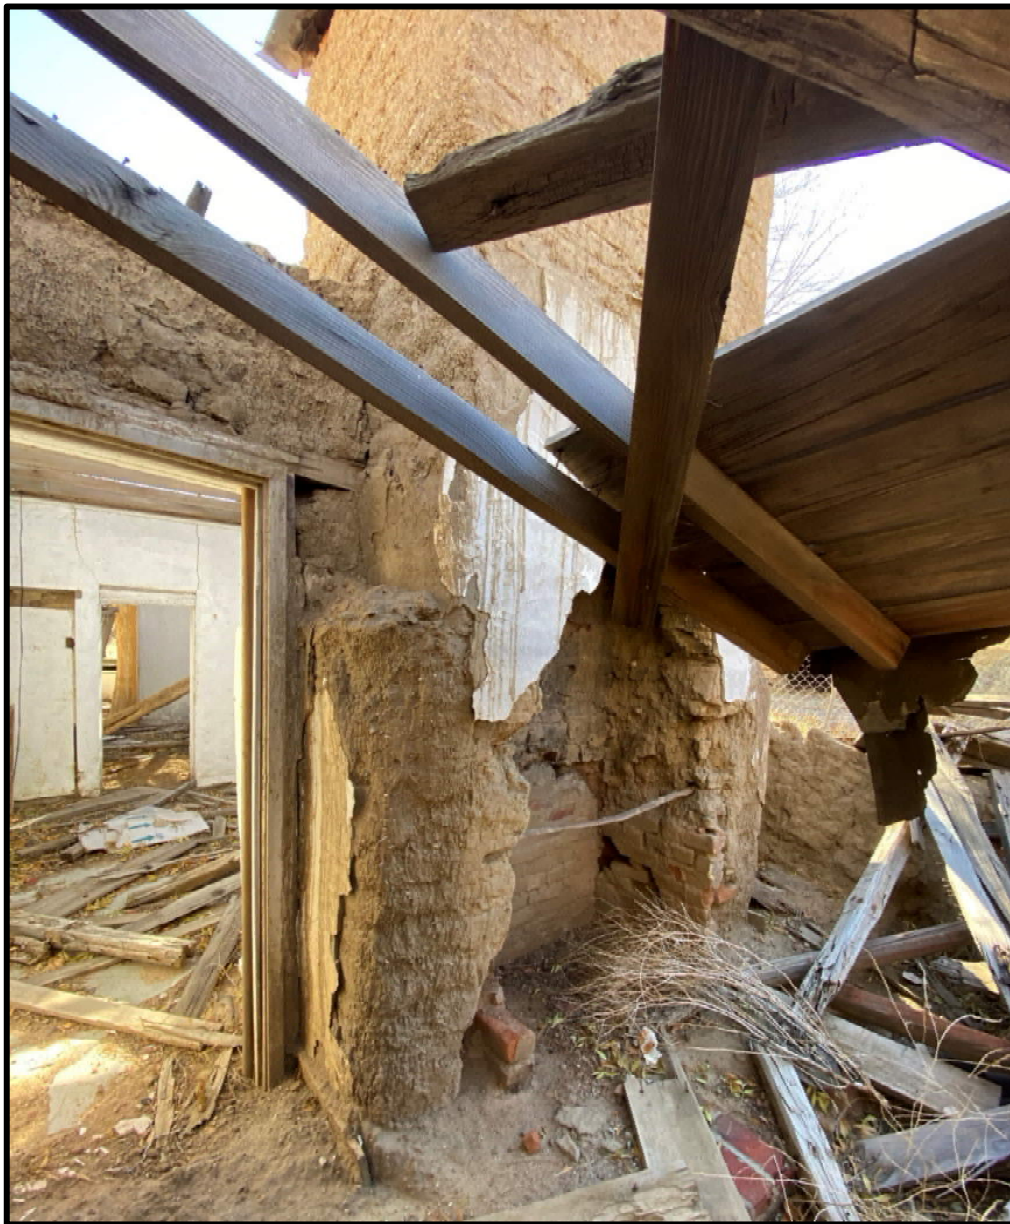
The chimney is one area where the structure is in slightly better condition. The chimney sits in the space between the two rooms of the original adobe and has a hearth in each room. There is brick masonry incorporated into the chimney, which could be original as its not uncommon to see fired brick incorporated into adobe where higher strength was needed. While the adobe itself has still experienced significant deterioration the fireplace and chimney have largely kept their shape and only small areas are completely missing. The chimney has a bit more inherent stability than the free-standing walls just given the larger width, but without a roof to provide bracing is still extremely vulnerable to seismic forces.

North side of Chimney at Original Adobe

There are some localized areas such as the chimney and a couple wall segments that could be stabilized in-situ as ruins with significant structural reinforcement and bracing. This would

involve removing the roof and taking the loose material and rest of the walls down to mitigate the life safety risk.

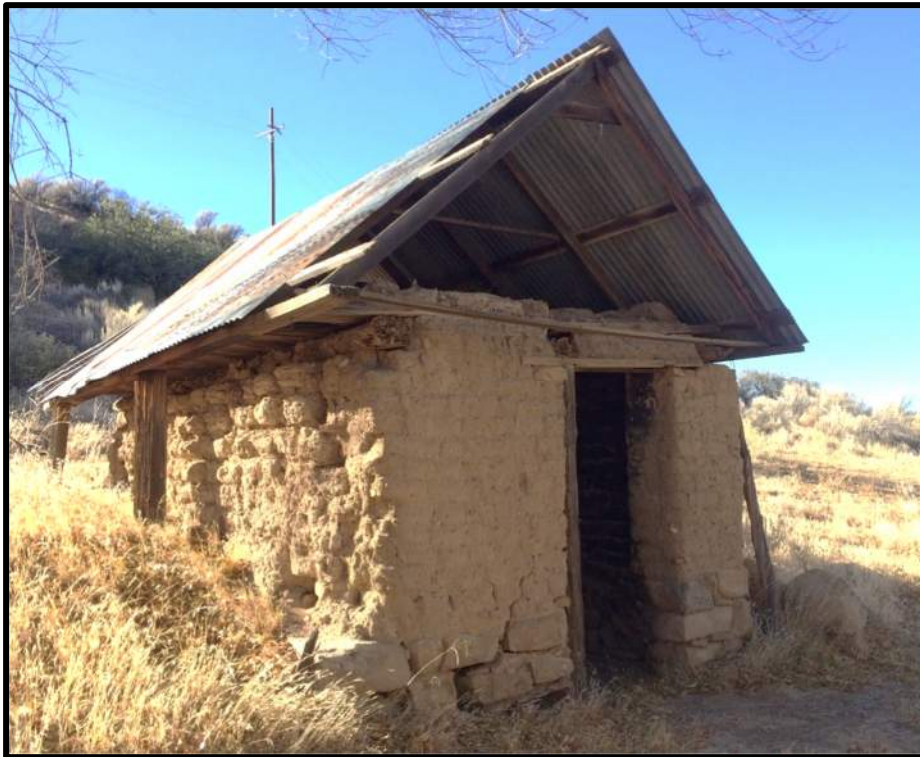
The 1850s original smokehouse is in by far the best condition of any of the other adobes on the site. All four walls are also still intact with varying degrees of missing blocks, cracking and deterioration. The roof structure is still largely in place which has certainly helped the condition of the adobe. The roof itself, which is a combination of sheet metal over wood framing is in fair to poor condition and likely to fail without structural intervention in the next couple of years.

In any of the above options the Smokehouse is the one area where restoration appears the most feasible from a structural perspective. While there would still need to be significant repairs at both the masonry and roof it is presently still in a condition where it can be saved. In addition to repairs to restore the structural integrity of the walls and roof the building would be seismically retrofit with an interior bond beam and better connection to a roof diaphragm.
