Phase II Historic Resources Report Agromin Commercial Organics Processing Operation, Edwards Ranch Road, Santa Paula

19 May 2017

County of Ventura
Notice of Preparation of an EIR
PL17-0154
Attachment 13 - Phase II Historic
Resources Report

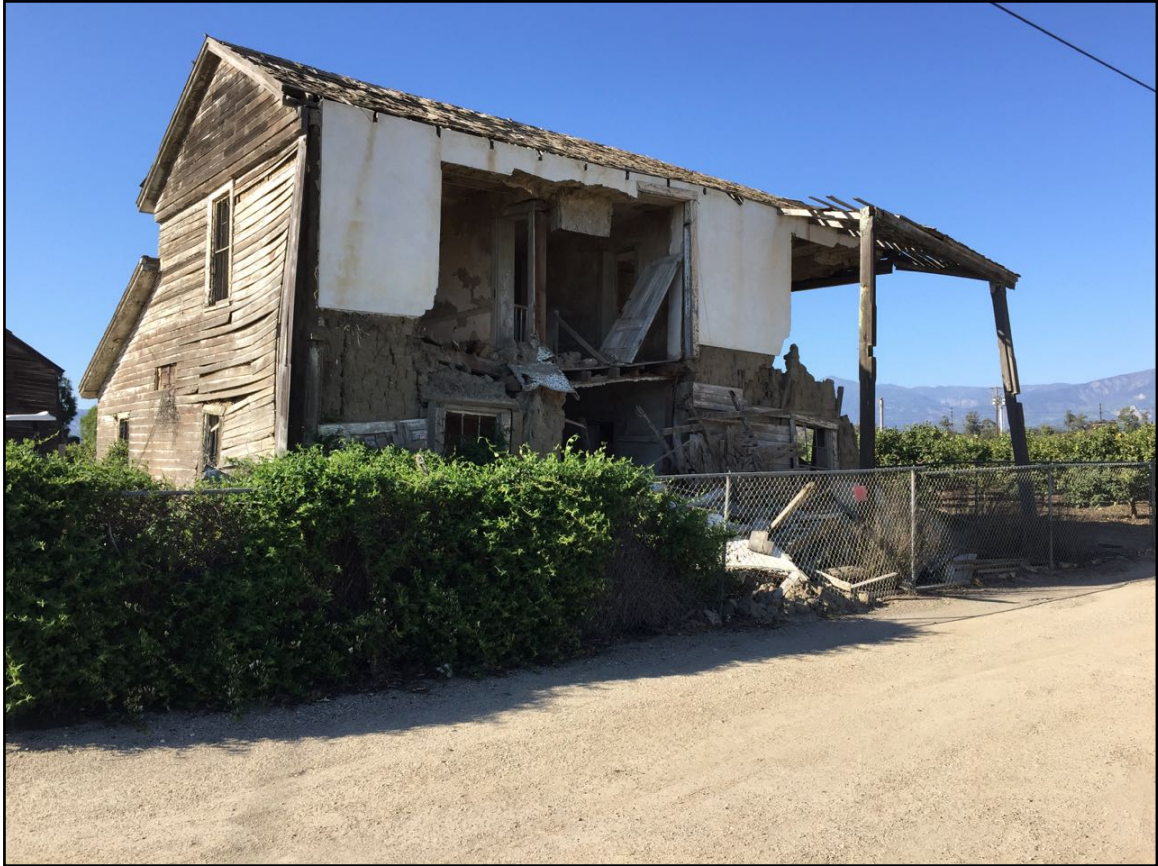
Photo 1. More-Edwards Adobe, southern and western elevations. [3-31-17]

The most notable change to take place in this cluster since the completion of the survey in 1996 is the severe structural damage to the More-Edwards Adobe, a building that has been deteriorating at a previously more gradual rate since the time it was last inhabited in 1956. Over the last few years, a substantial portion of the building's eastern wall and a portion of the southern wall have collapsed. The two-story porch on the southern elevation is now almost entirely missing. Wood lap siding covering the adobe wall on the western elevation is bowed in places, suggesting the presence of structural trauma in the wall underneath. The wood shingle roof appears to not be watertight.

Advisory Item: Although not a part of the project site or under the control of Agromin, the stabilization and protection of historic buildings currently exhibiting signs of deterioration and structural trauma should be addressed through the development of a comprehensive historic preservation to provide for the future maintenance and continued historically appropriate use of buildings within the historic district, and arresting the deterioration process in the immediate term. The plan should also address longer-term issues of maintenance and use in a historically-appropriate manner.

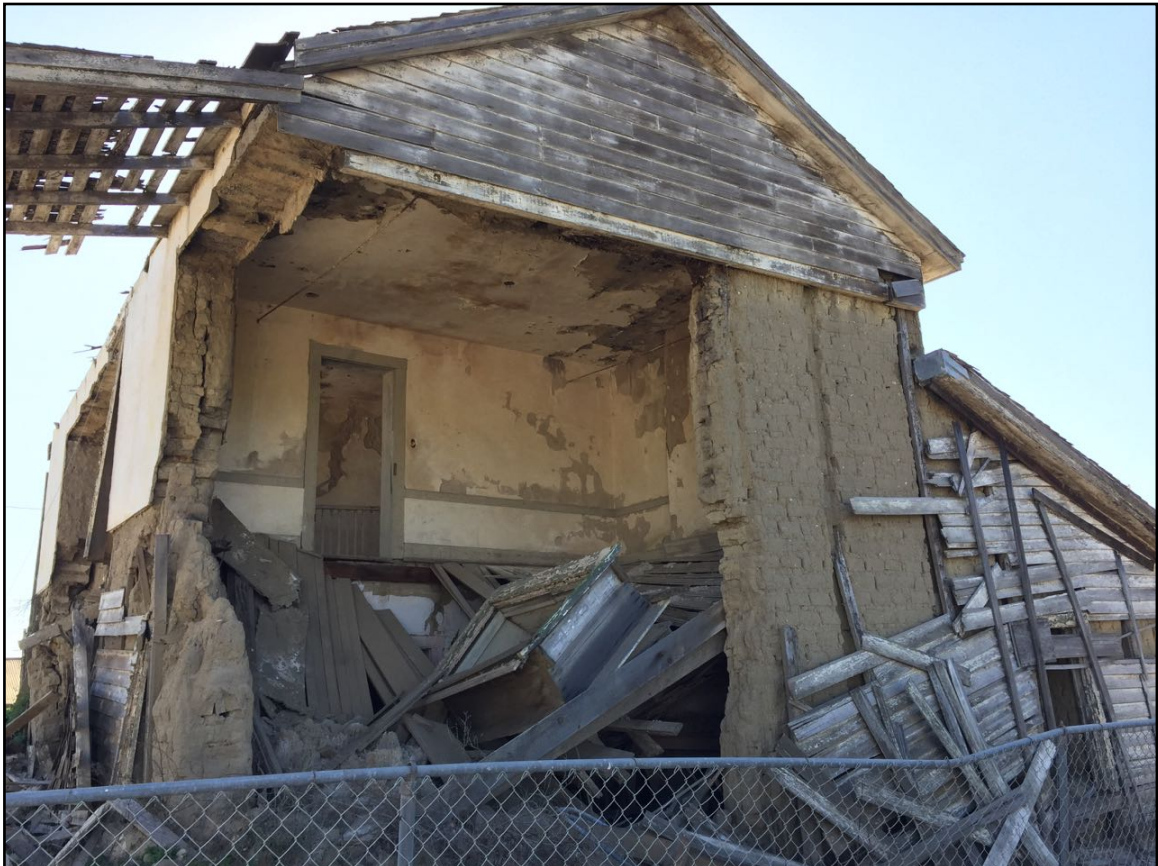
Photo 2. More-Edwards Adobe, eastern elevation. [3-31-17]

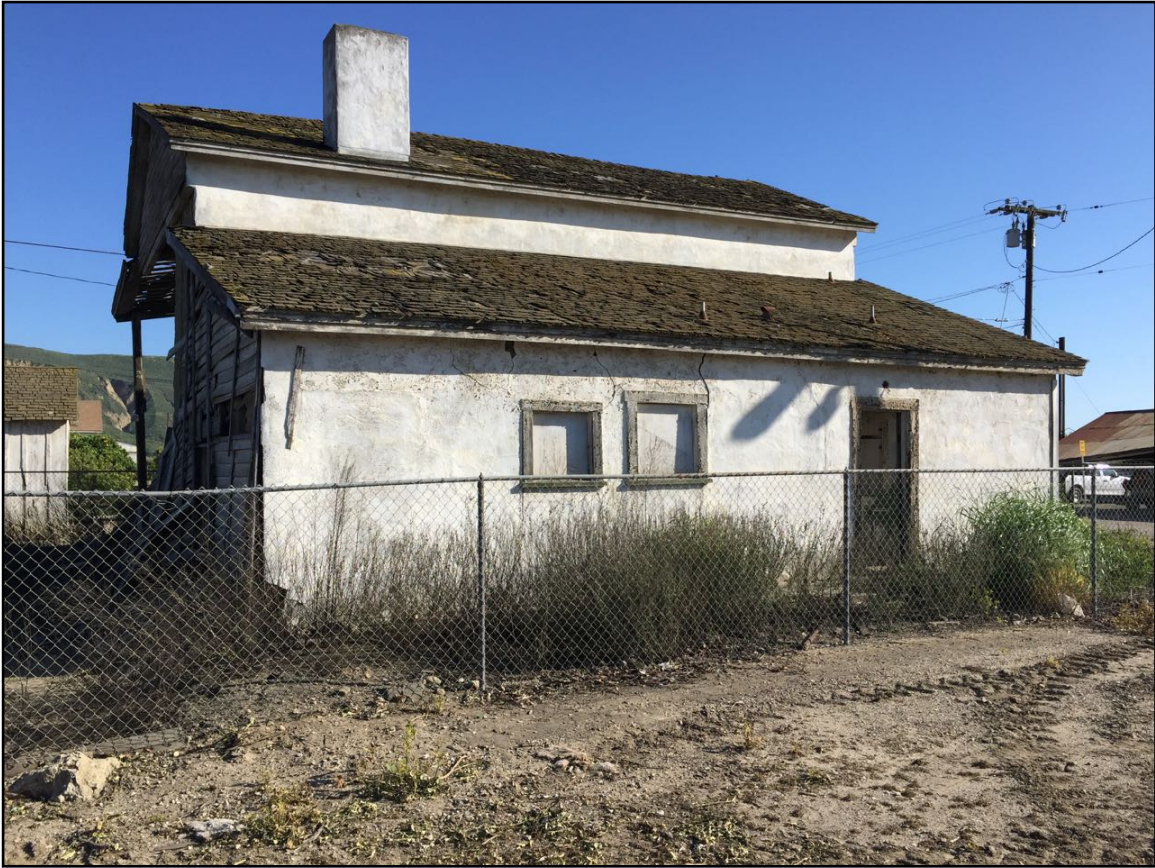
Photo 3. More-Edwards Adobe, northern elevation [3-31-17].

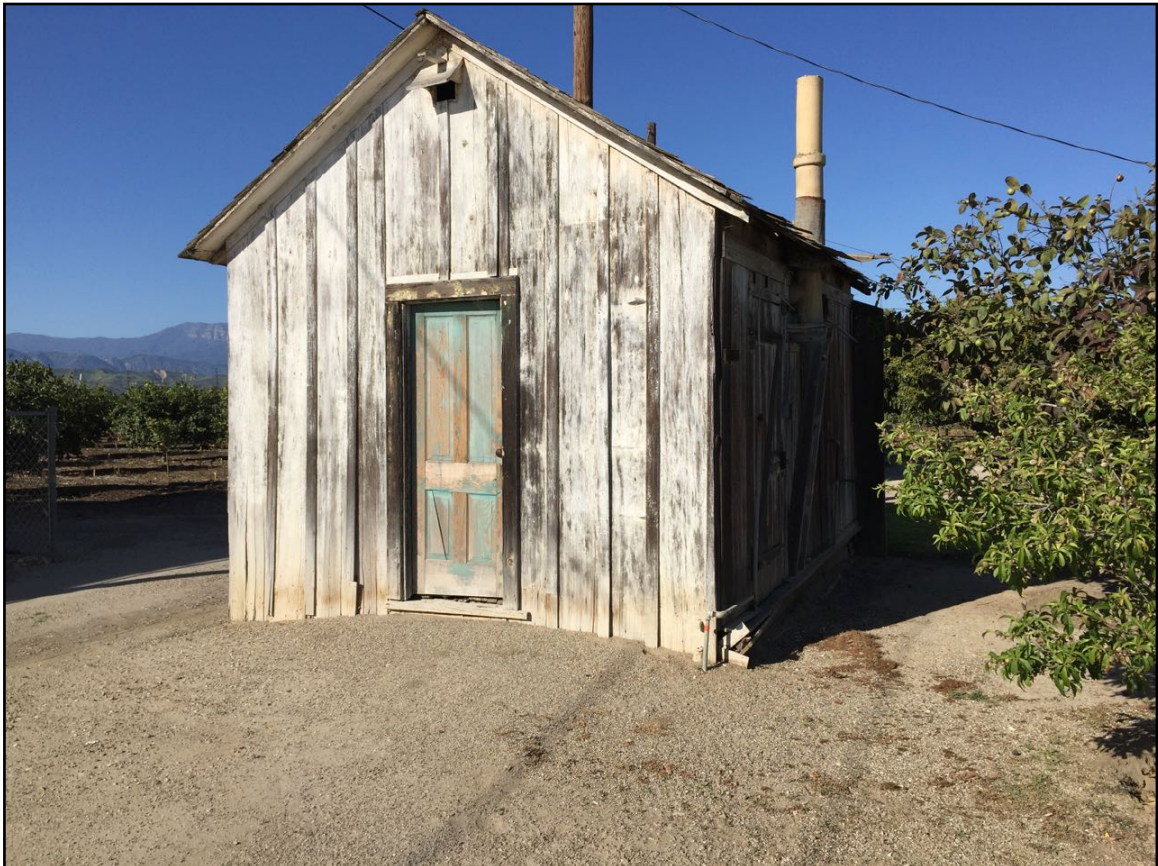
The other buildings in this grouping are largely unchanged from the date of the survey. A minor exception is the removal of a lean-to wing from the southern elevation of the office building (See page 9, Appendix A, Photo 4). This lean-to wing was likely a later addition to this building. The row of buildings including the schoolhouse are in a somewhat more deteriorated condition than they appeared in the survey, with the loss of some siding and roofing materials. (See pages 7-8, Appendix A, Photo 5).

Photo 4. Office Building, western elevation. [3-31-17]

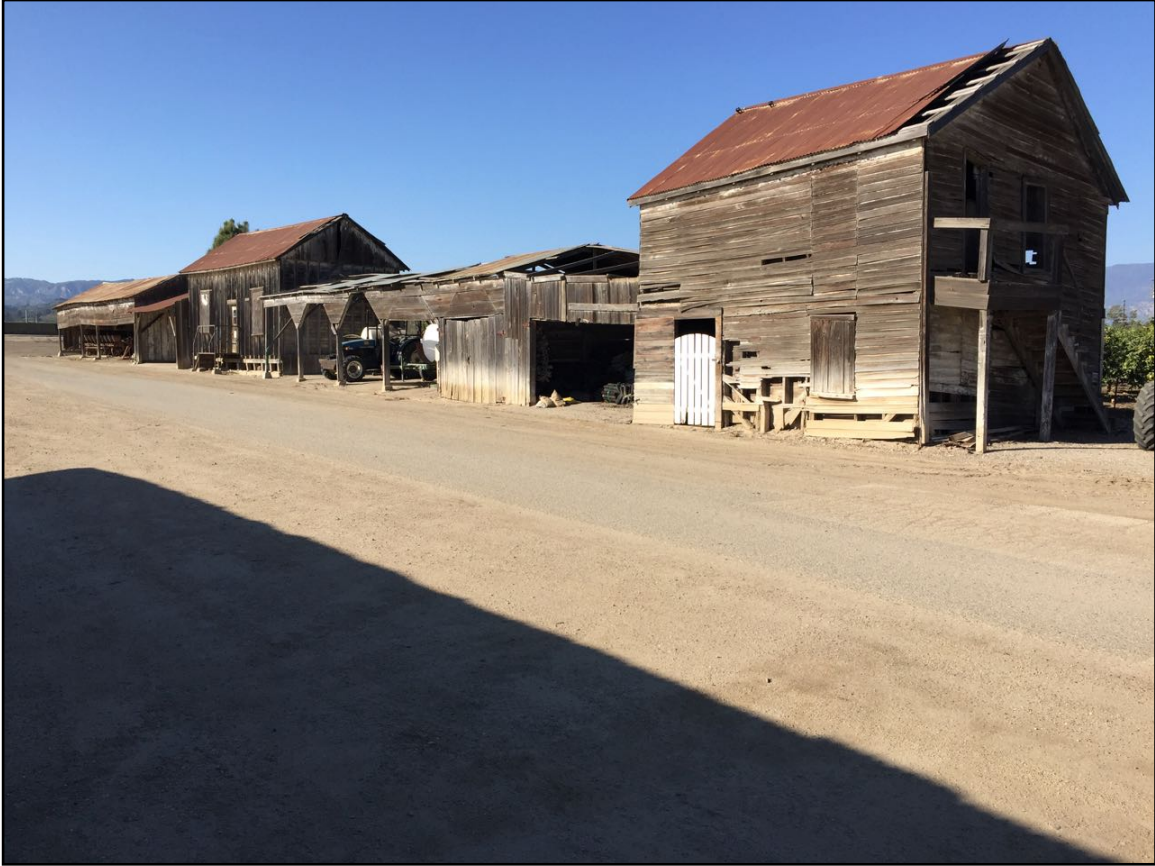
Photo 5. Barns and schoolhouse, western elevation. [3-31-17]

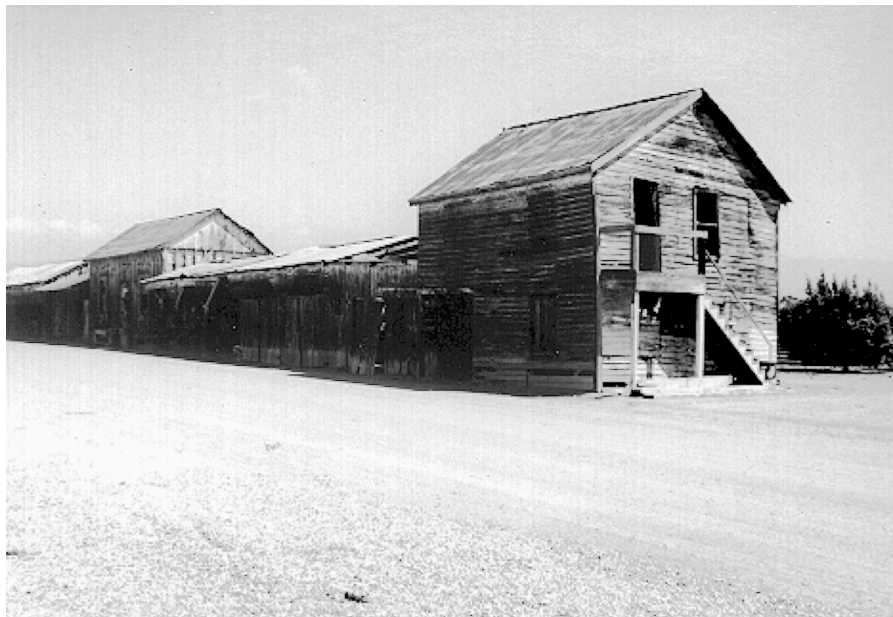
This cluster of five connected buildings is presently used for equipment and vehicle storage. Some of the buildings may have been moved on the site. From south to north, the first building on the south is a two-story wood frame building that was probably originally used as a residence. It has a medium gable roof covered with corrugated metal siding and a square plan. Windows have been boarded up. The only remaining door is a five paneled door with an outside staircase leading up to it on the southern elevation. The house is covered with wide horizontal wood siding and has no foundation.

North of the school are gable roofed storage sheds with corrugated metal roofs. Portions of the sheds have wood siding and portions are open for vehicle and equipment storage. All the buildings are in a deteriorated condition.

P5b. Description of Photo: (View, date, accession)
Sheds, southeast elevation, 5/03/95, #0613

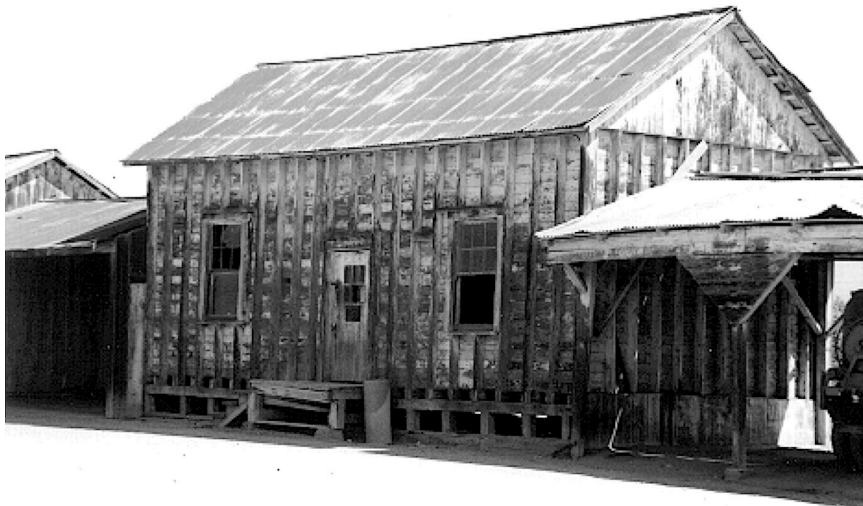
North of the equipment shed is a small rectangular plan building with a medium gable roof. It is believed to be the old Live Oak School, originally located at the corner of Olive and Telegraph roads. It is symmetrical in design with a centered front door flanked by two windows on the western elevation. The windows have six panes in the upper sash and a single pane in the lower sash. This windows treatment is repeated on the eastern elevation. Many of the panes are broken, and this building, like the rest in this grouping, is badly deteriorated. This building is architecturally interesting because it is built with wide horizontal siding single-wall construction, but with the studs on the outside. The building rests on a wood foundation.

Description of Photo: (View, date, accessio
Schoolhouse, east elevation, 5/03/95, #0615

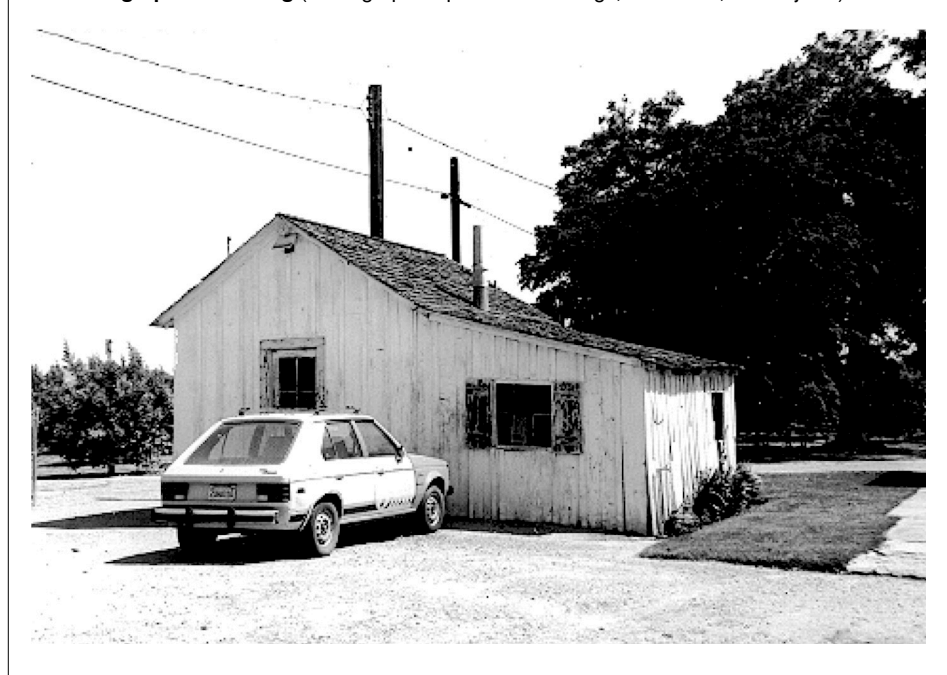
P3. Description (Describe resource and its major elements. Include design, materials, condition, alterations, size, setting, and b)
Adjacent to the two-story adobe residence is a small office building. It is rectangular in plan with a medium front facing gable roof and shed roof extension on the south side, covered with wood shingles. Under the open eaves are short exposed rafter tails. The building has a single front door with four glass panes and a six-paned wood window to the south. The window has wood shutters. A garage is located behind the office. The building is in fair condition.

P5b. Description of Photo: (View, date, accession)
Office, west elevation, 5/03/95, #0607

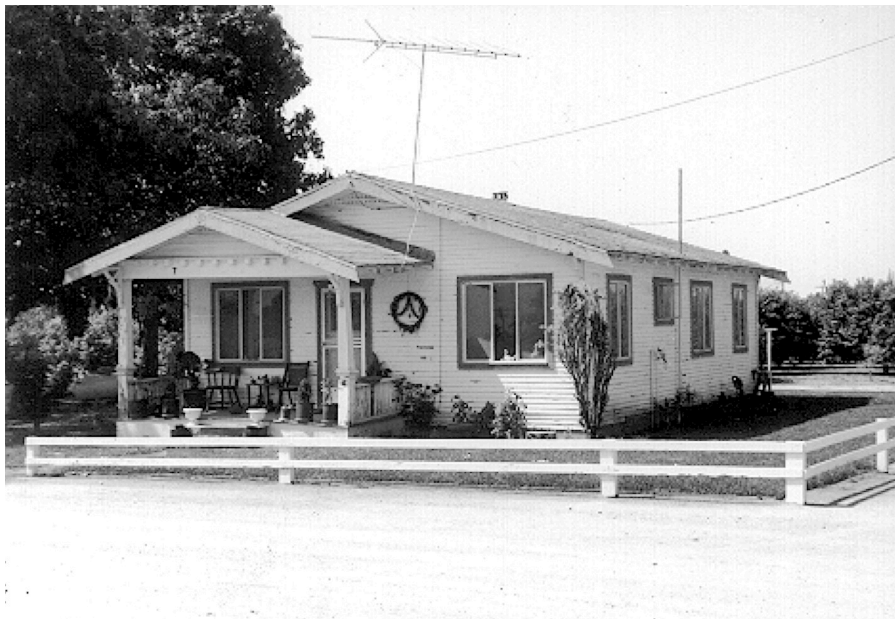
This is a one story California Bungalow style residence with a rectangular plan and a front-facing low-pitched, gable roof covered with composition shingles. A projecting porch with a vertical slat baluster is located on the left side of the house, and is supported by tapered columns. The house is covered with narrow, horizontal clapboard siding and rests on a concrete block foundation. The open eaves have exposed rafter tails and knee-brackets. Lattice vents are found under the gable ends. The house has aluminum sliding windows with plain wood casings. At the rear of the house is a small wood shingle clad hip roofed shed with multi-paned windows and wide horizontal drop siding. An open fence extends across the front of the house containing a small yard and large mature tree. The house is in fair condition.

P5b. Description of Photo: (View, date, accession) Residence #7, northeast elevation, 5/03/95, #0606

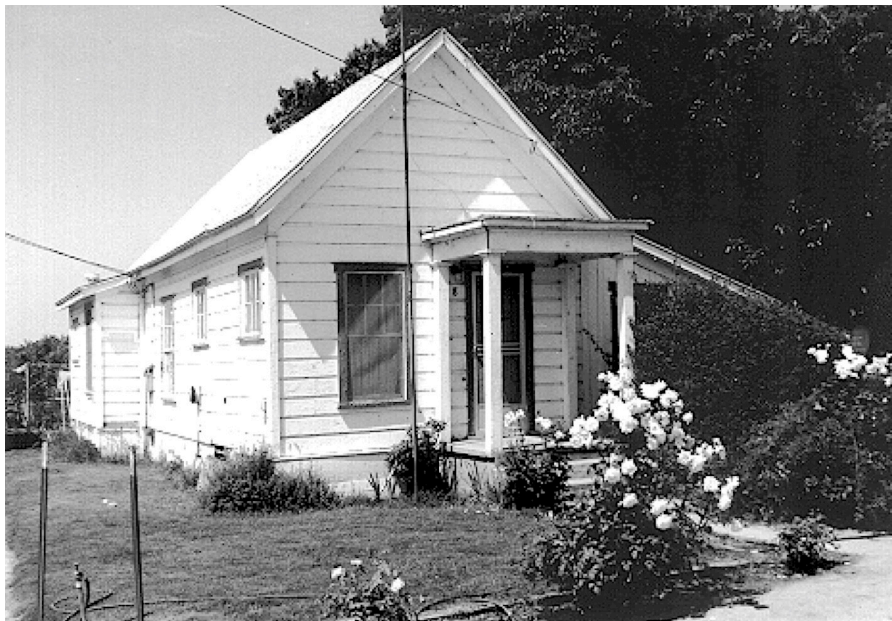
This is a one story folk style residence with a rectangular plan and a front-facing high-pitched, gable roof covered with composition shingles. A projecting porch, modestly Greek Revival in style, with a flat roof is located on the right side of the house, and is supported by capped square posts. The house is covered with wide, horizontal shiplap siding and rests on a partial concrete block foundation covered by a wood skirt. The closed eaves have a frieze band under the gable ends. The house has medium, multi-pane, double-hung windows with plain wood casings. The windows have six panes on the upper sash over a single pane on the lower sash. A shed roof addition has been made to the northern elevation of the house with additions to the rear as well. The house is in good condition.

P5b. Description of Photo: (View, date, accession)
Residence #8, southeast elevation, 5/03/95, #0604

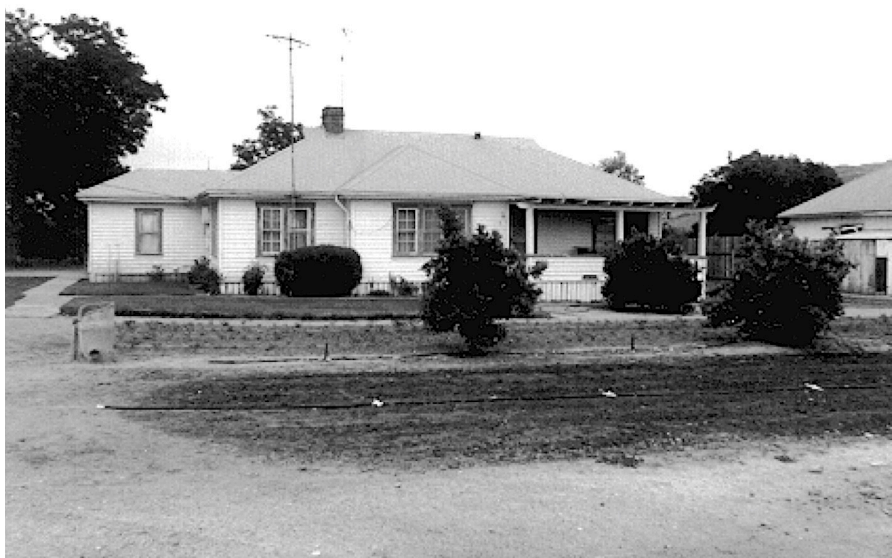
Facing the road, just south of the office, is this one story gable-on-hip roof residence covered with composition shingles. Eaves are closed with lattice vents on the south end and a louvered vent on the north end. The porch is recessed on the south side of the building, and is supported by square supports below exposed rafters and beam. The balustrade is enclosed with wood siding to match the house. Windows are found singly, in pairs and in threes. Some windows are double-hung four-over-four panes with wood casings. The house is covered with medium horizontal clapboard siding and rests on a concrete or wood pier foundation covered with a wood skirt. A brick chimney punctuates the roofline. The house has retained its integrity and is in good condition.

P5b. Description of Photo: (View, date, accession)
Residence #9, west elevation, 5/08/95, #1200

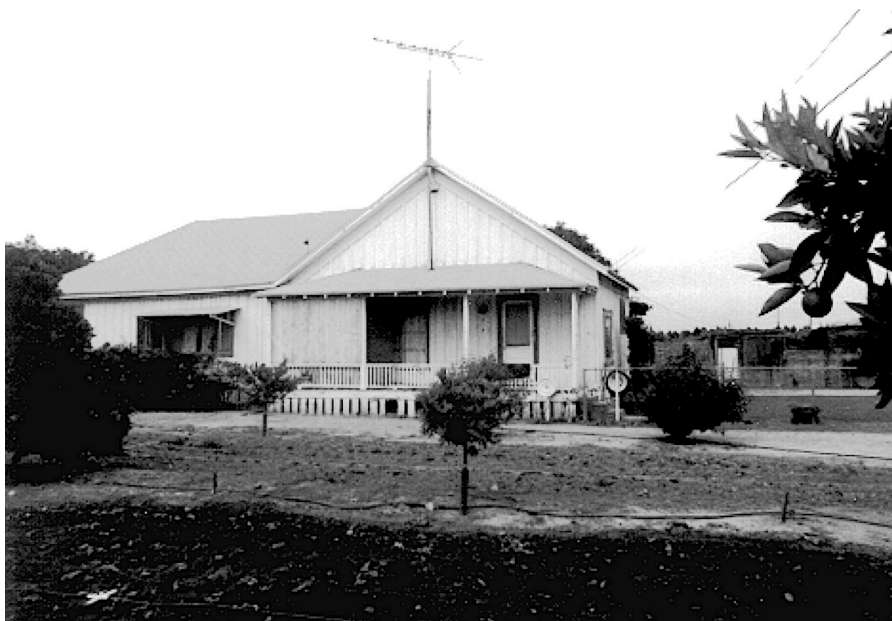
This is a one story residence with an I-shaped plan and a front-facing medium-pitched, gable roof covered with composition shingles. The shallow eaves are open. A projecting porch with a hip roof and exposed rafters and a spindle baluster is located on the right side of the house, and is supported by square posts. The house is covered with board and batten siding and rests on a concrete perimeter foundation covered with a vertical board skirt. A brick chimney is located on the ridge of the house. The house has a large front multi-pane wood window next to the front door and an aluminum slider windows with plain wood casings north of the porch. The single door has vertical panels. Changes to this folk house with its gable front and wing plan are seen in the partial enclosure of the front porch and changes to front windows. Behind the house is a small shed roof tool shed, a wood carport with metal roof and a basketweave wood fence. The house is in fair condition.

P5b. Description of Photo: (View, date, accession)
Residence #10, west elevation, 5/08/95, #1201

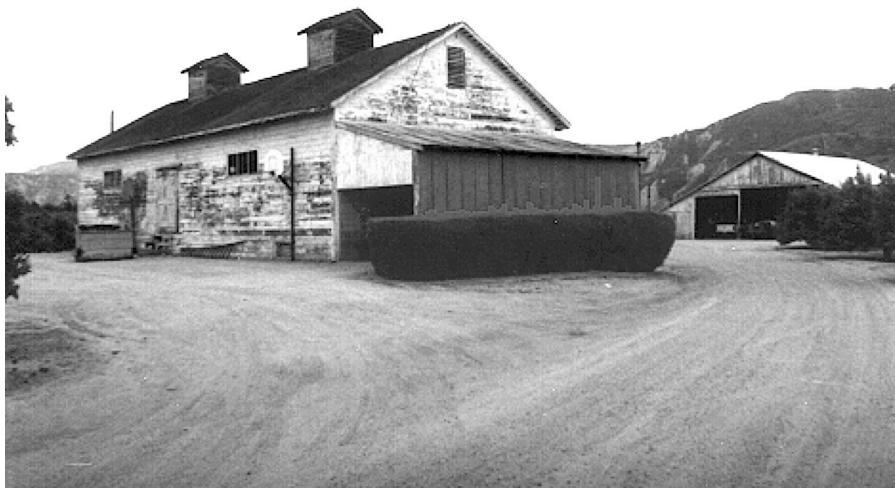
South of the residential area is a cluster of large barns. One is long, rectangular in plan, one-and-a-half-stories in height with a medium high gable roof topped with two gabled cupolas with louvered vents. The building is covered with wide horizontal drop siding and has several large sliding wood doors on tracks. A single-story shed roof board-and-batten addition is located at the west end. The building rests on concrete piers at the corners. The building is in fair condition.

P5b. Description of Photo: (View, date, accession)
Barn, northwest elevation, 5/03/95, #0602

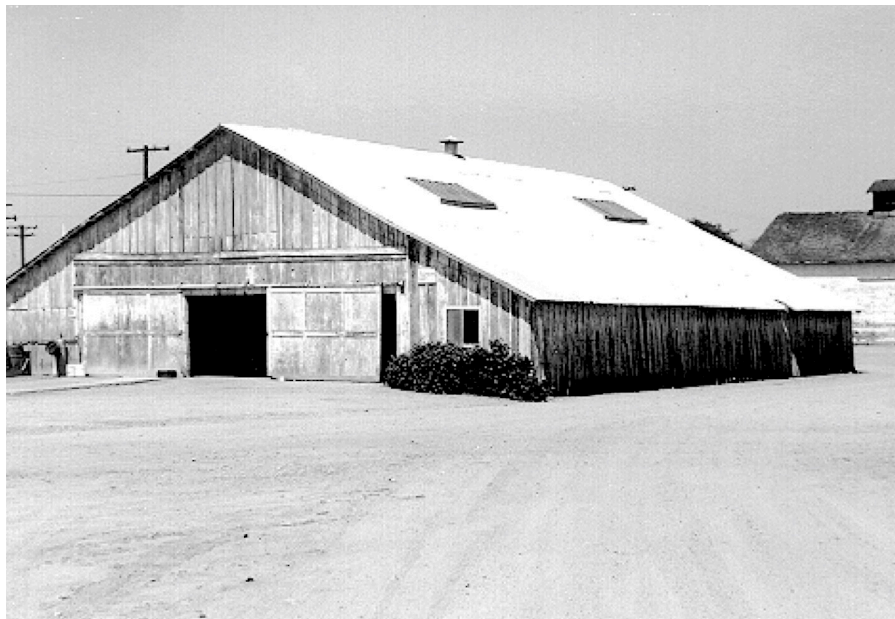
Behind and to the south of the barn is another one-and-a-half-story barn with a medium pitched gabled roof. The roof is covered with corrugated metal and the building with board-and-batten siding. A large openings on the southern and northern elevations are covered by large wood doors rolling on metal tracks. The building is in fair condition.

P5b. Description of Photo: (View, date, accession)
Barn, northwest elevation, 5/03/95, 0601

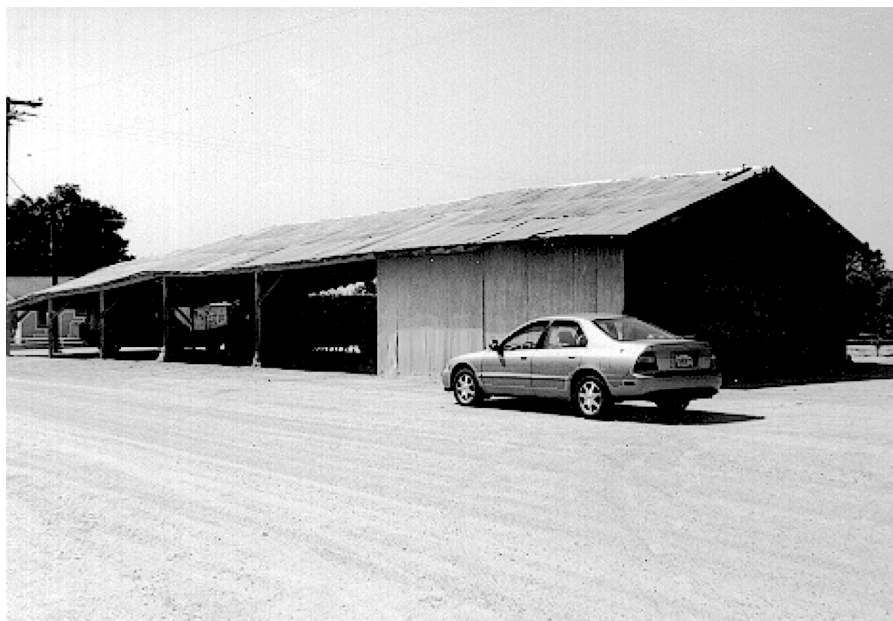
Located to the west of the cluster of ranch buildings is a long implement shed used for storage of agricultural equipment and automobiles. The shed is covered with a low gable roof of corrugated metal and supported by square wood posts on concrete piers. The building is partially enclosed at the north end with corrugated metal siding. It is in fair condition.

P5b. Description of Photo: (View, date, accession) Implement shed, northeast elevation, 5/03/95, 0610

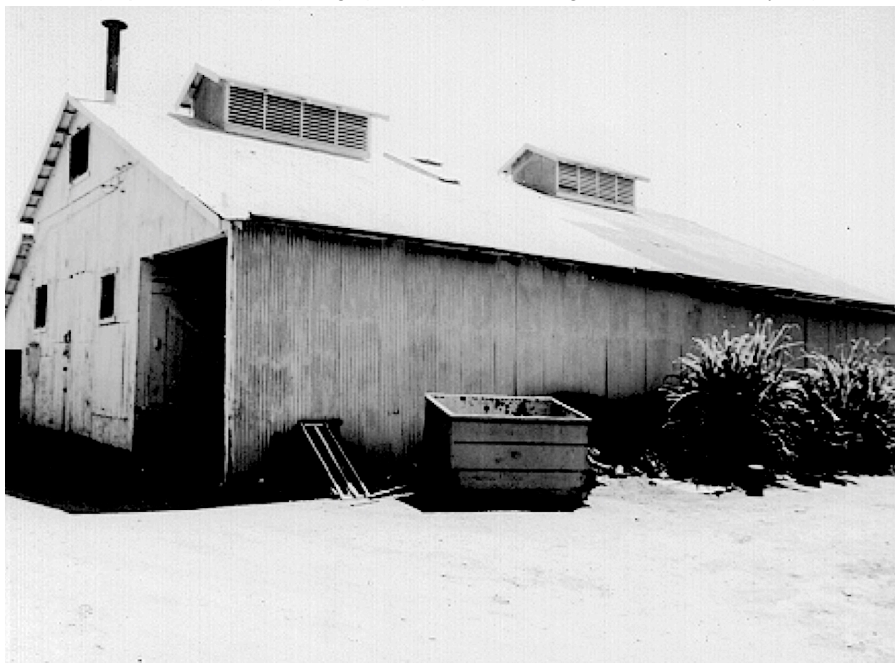
This rectangular plan building has a high pitched gable roof covered with metal siding and two small gabled and louvered vents at the ridge line. The gable on the eastern elevation is broken and forms a shed roof that extends low on the corner of the building. The west end is partially open with corrugated metal siding. There are other small openings on the north side of the building. The building is covered with vertical wide board siding.

P5b. Description of Photo: (View, date, accession)
Barn, northwest elevation, 8/21/95, #1612

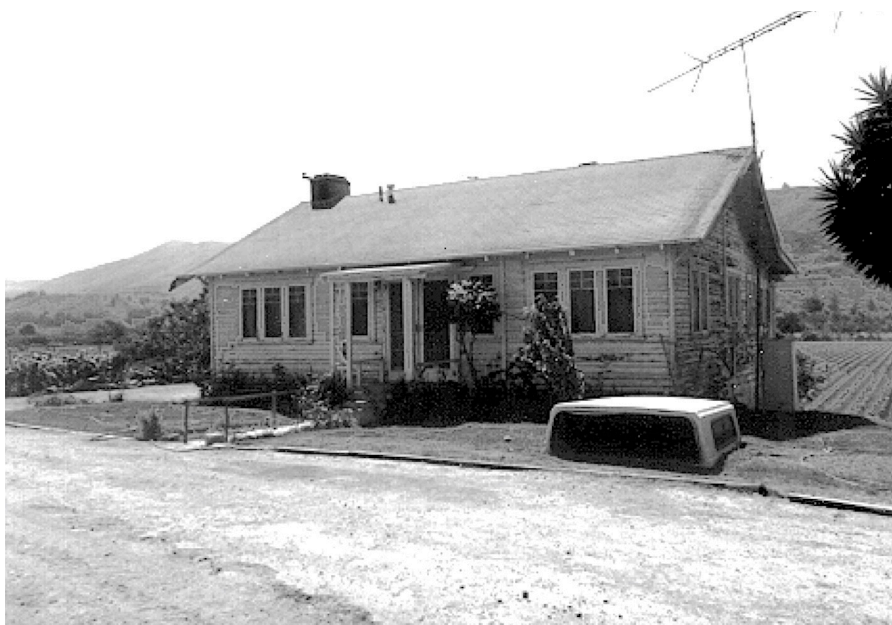
This is a one-story California Bungalow style residence with a rectangular plan and a side-facing medium-pitched, gable roof covered with composition shingles. A projecting porch with a vertical slat baluster is centered on the front of the house, and is supported by double square posts with a decorative wood pattern between the posts. The house is covered with alternating narrow and wide horizontal clapboard siding and rests on a wood pier foundation. The open eaves have exposed rafter tails and knee-brackets. It has lattice vents under the gable ends. A brick chimney is located on the east side of the house. The house has narrow, four-over-one, casement windows with plain wood casings. The house is in fair condition.

P5b. Description of Photo: (View, date, accession) *Residence, northwest elevation, 5/08/95, #1212*

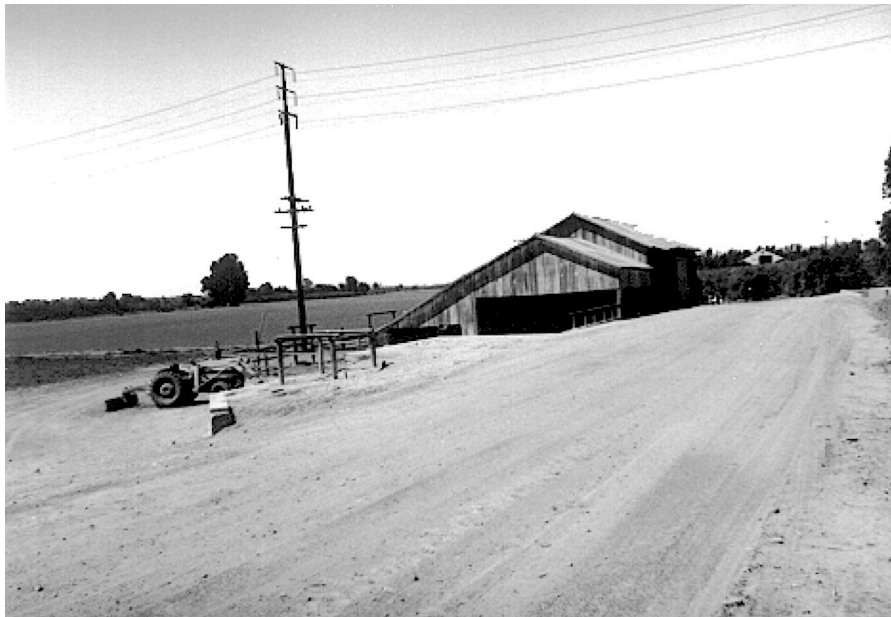
West of the house is a single car flat roofed garage and a large two-story barn. The barn is built against the hillside and has a long saltbox type roof on the east side with a gable roof on the taller west side. The barn is covered with wide vertical board siding.

Description of Photo: (View, date, accessio
Barn, east elevation, 5/08/95, #1211

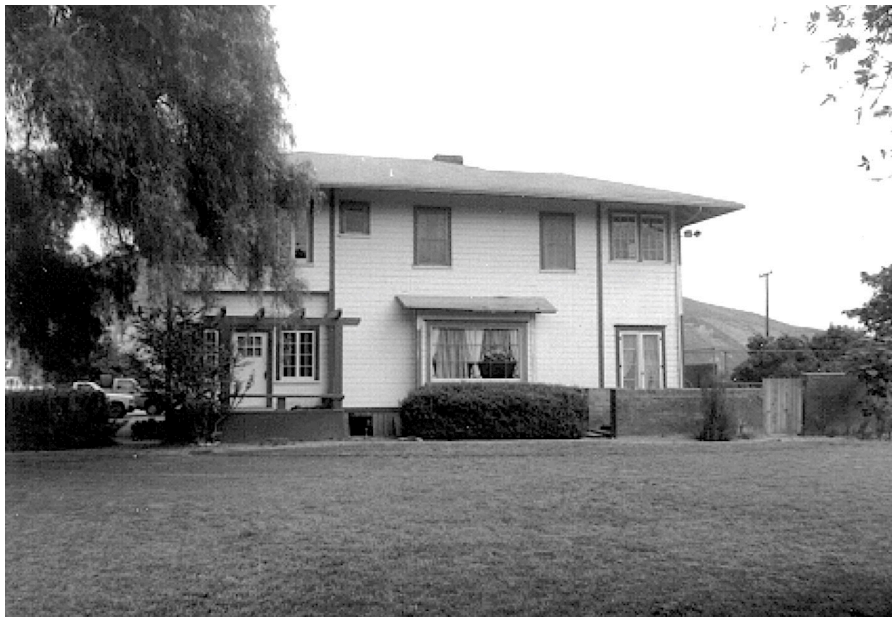
A somewhat rare example of Prairie style architecture, this two-story residence has a low pitched hip roof covered with composition shingles and built in a t-shaped plan. Decorative rafter tails are found under the broad open eaves. A band of wood casement windows wraps around three sides of the second story. In addition, multi-paned double hung windows are located on both the first and second floors. The first floor also has a French door located on the west end of the front facade. The front porch, located on the eastern elevation, has a small concrete stoop and brick foundation with a centered door flanked by casement windows. The single wood door has four panes in the upper half. A pergola projects over the porch. A large rectangular bay window, covered with a short shed roof, projects from the center of the house. A very large window, divided into four narrow panes, is located on the eastern elevation, over the stair landing. The first floor windows have shelf mouldings with plain wood casings on the second floor windows. The house features three brick chimneys, one on the east, the west and in the center of the roof. The house is covered with wide horizontal beveled siding and rests on a wood and concrete pier foundation covered with a vertical board skirt. The house is in good condition with only minor alterations. A concrete block porch and metal railing replaced an earlier wood porch at the rear east side of the house.

P5b. Description of Photo: (View, date, accession)
Residence, north elevation, 5/08/95, #1206

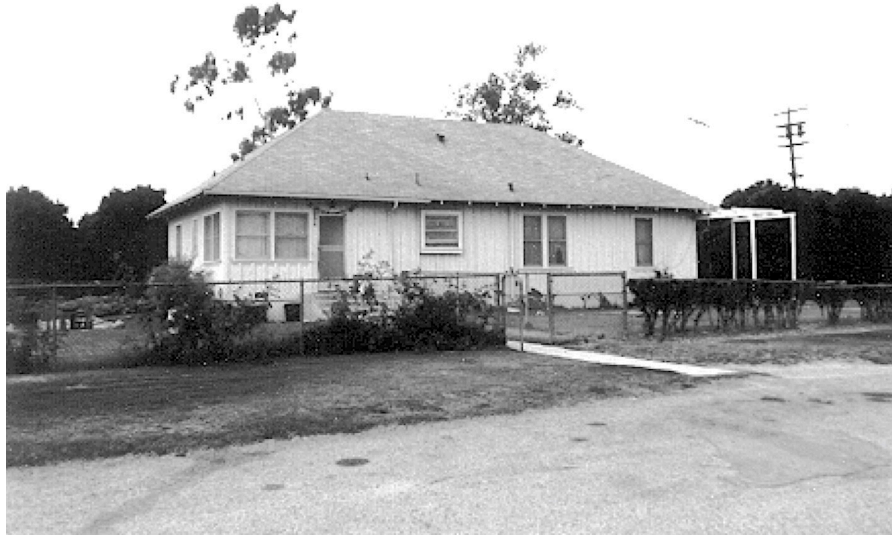
This is a one-story Cottage style residence, built ca 1912, with a rectangular plan and a medium-high pitched, hip roof covered with composition shingles. Exposed rafters are located under the open eaves. Windows are one-over-one wood sash with wood casings found in pairs or singly. A pergola extends from the north elevation. The house is covered with board-and-batten siding and rests on a concrete perimeter foundation.

Description of Photo: (View, date, accessio
Residence, east elevation, 9/07/95, #1807

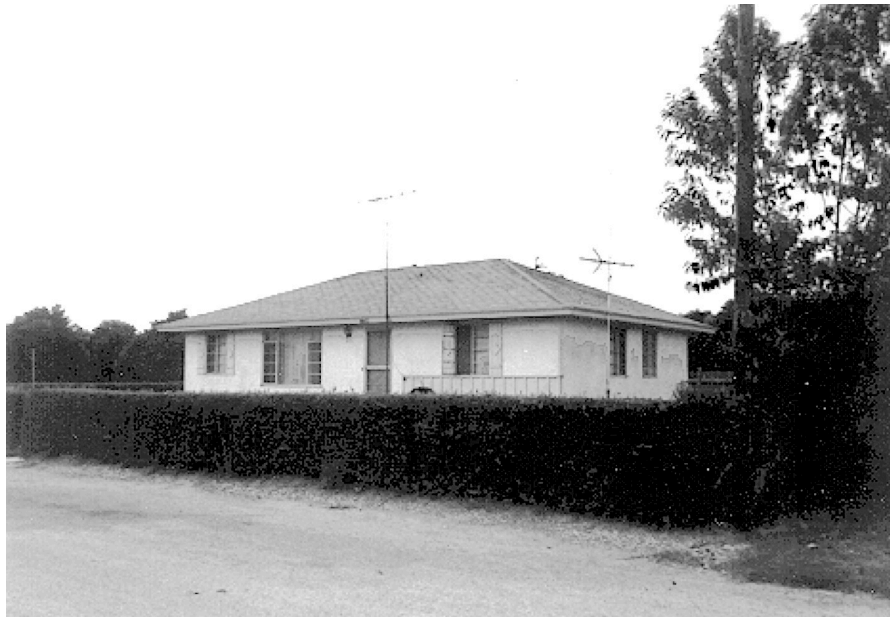
This is a one-story ranch style residence, built ca 1940, with a rectangular plan and a medium-pitched, hip roof covered with composition shingles. The house is covered with stucco siding and rests on a concrete perimeter foundation. The eaves are open. The house has medium steel casement windows with wooden shutters.

Description of Photo: (View, date, accessio
Residence, east elevation, 9/07/95, #1808
