**Re: Recommendations for Historic Preservation Compliance, Lockwood Valley Ranch,
Unincorporated Ventura County, California**

ATTACHMENT A: Photographs of Reyes Adobe

ATTACHMENT B: Structural Engineers Report

RE: Reyes Adobe
Silman Project No 3026.0030145

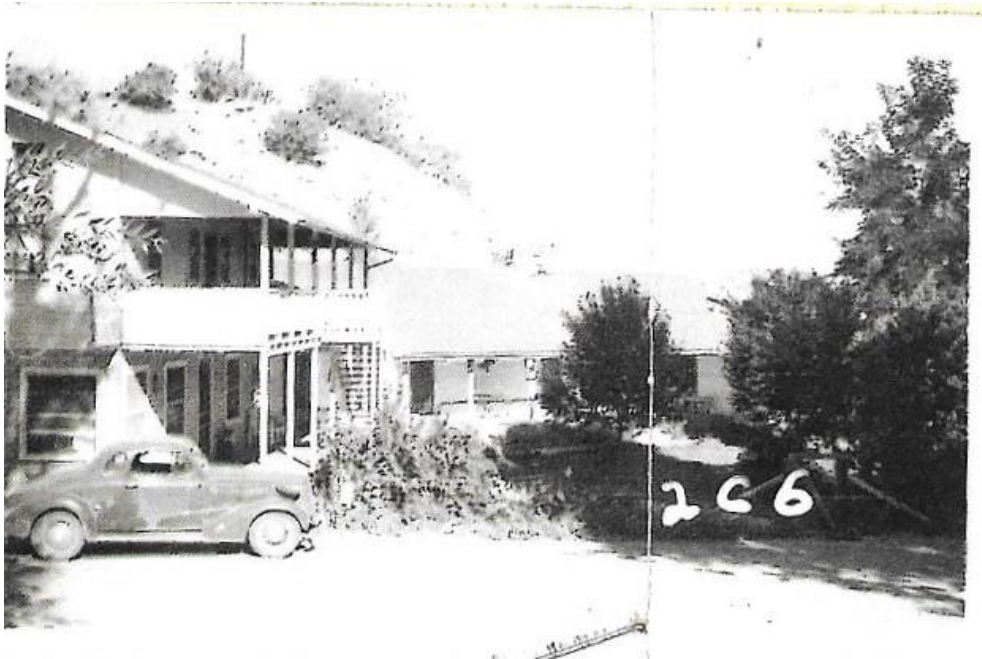
The Wheatleys owned the property until 1952, when Florence became ill (Ventura County Assessor; Hudson 2020). The property was assessed at the time and photos were taken of the extant buildings, including the adobe and its two-story addition (Figures 6 and 7). According to the assessor records, Jeff Butler was the owner of the property until sometime in the late 1960s. During this time a cabin was constructed on the property (1956) along with a horse barn and corral (1960). At the time of the landmark nomination in 1971, the owner of the property was listed as Joyce Campbell. Assessor records indicate the barn was demolished sometime between 1964 and 1965 although it was not marked as demolished until 1972.

Figure 6. County Assessor Records showing adobe and addition in 1952, view looking west.

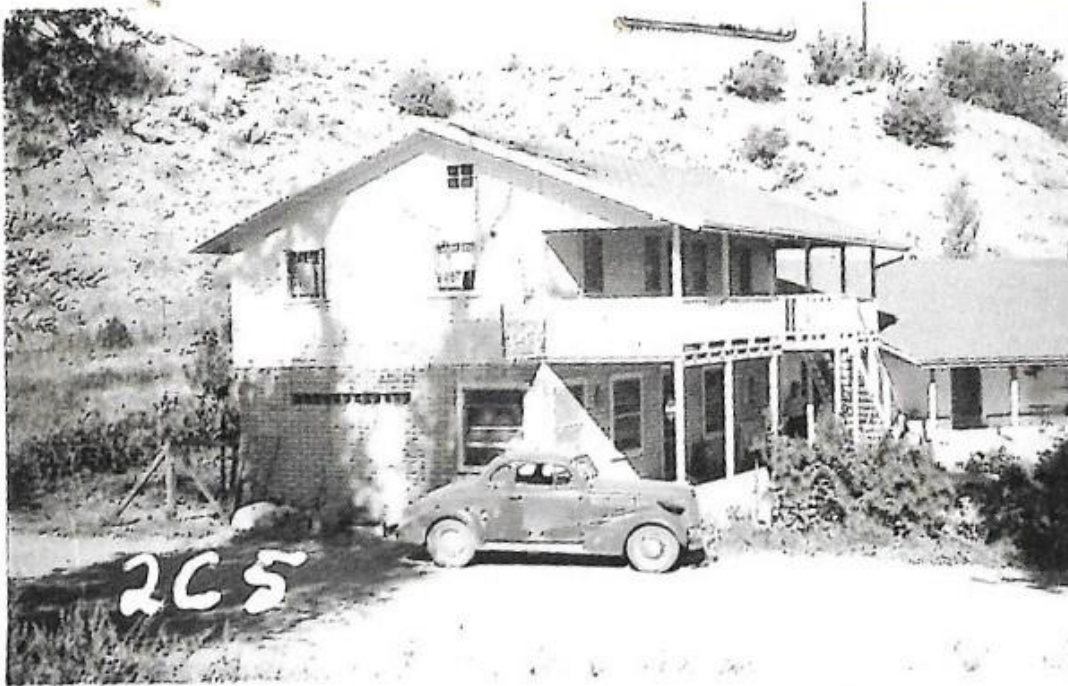
Figure 7. County Assessor Records showing adobe and addition in 1952.

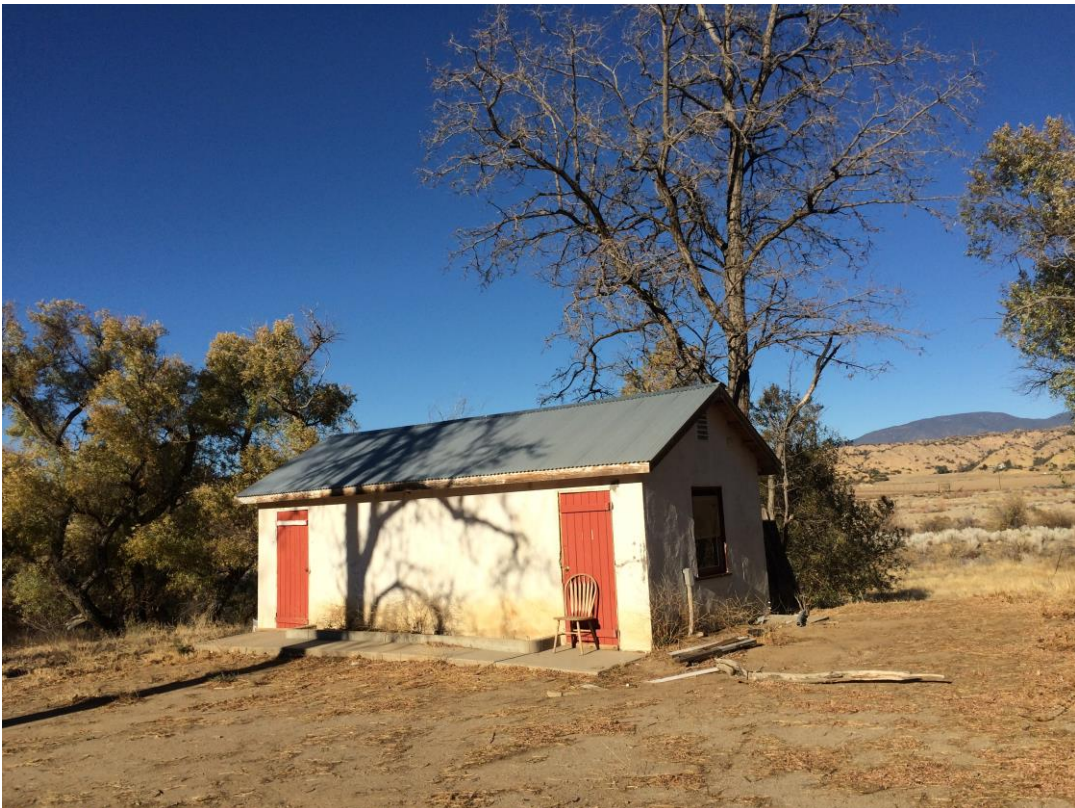
The Reyes Adobe is located in northern Ventura County on Lockwood Valley Road two miles east of Route 33. The main building consists of a two-room adobe constructed in 1854 with several alterations and additions made over the years, including a two-story addition on the south end (c. 1947) (Figure 8). Other buildings on the parcel include a smokehouse (1854) located approximately 15 feet west of the main building, a cabin (1956) (Figure 9) and a washroom (1947) (Figure 10).

Figure 9. View of cabin on property built 1956, looking northwest.

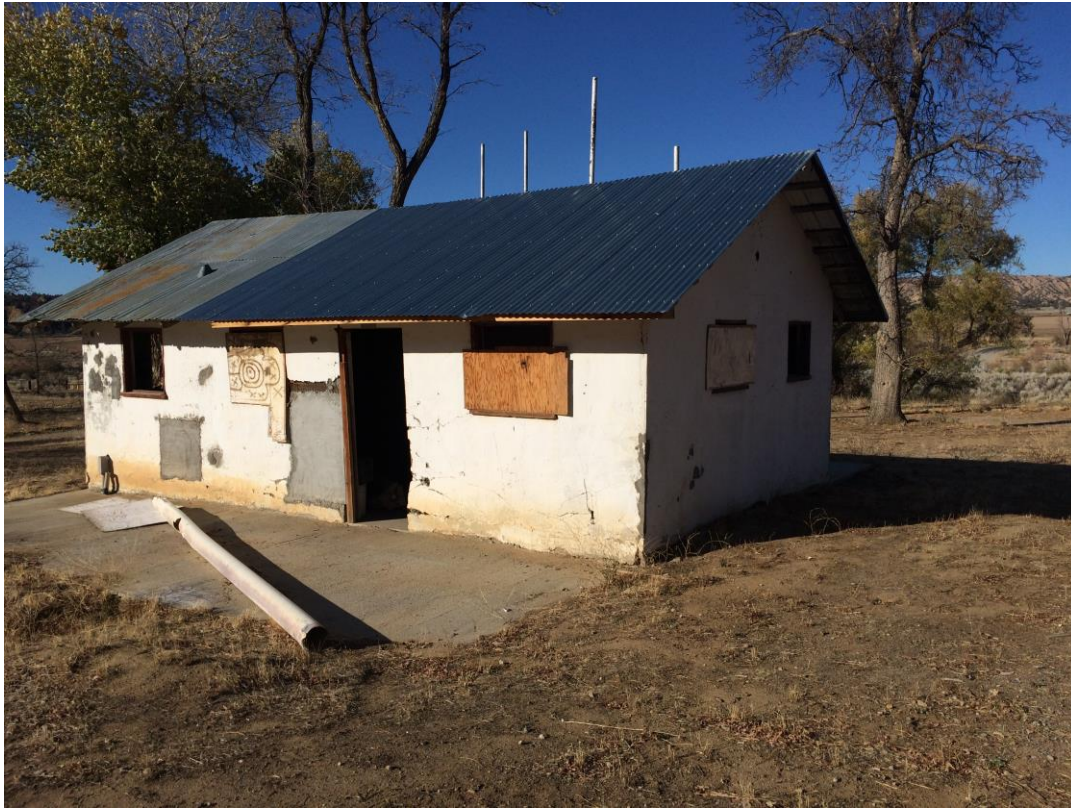
Figure 10. View of washroom constructed on the property in 1947, view looking northwest.

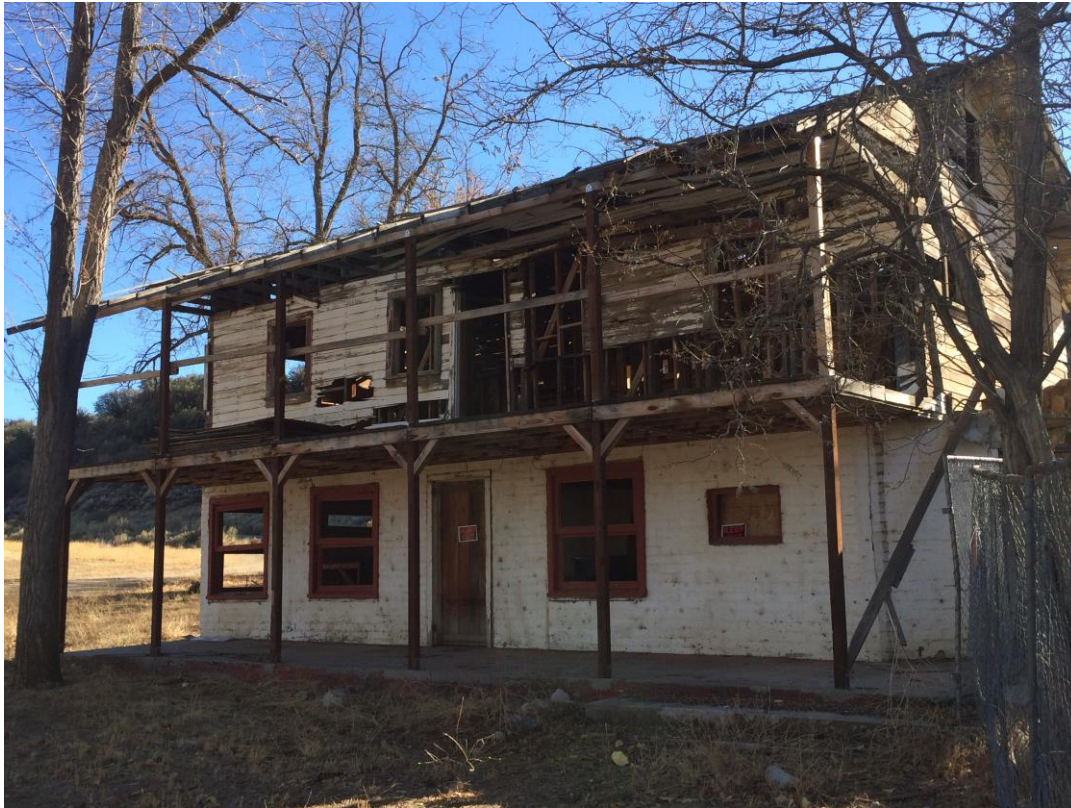
The adobe walls of the later additions to the north are still standing, indicating the original side gable shape of the roof (Figure 12). Portions of these walls have been covered with cement and have the only recognizable fenestration. A one-over-one sash window is located on the north façade and a clerestory window in the upper section of the west façade (Figure 13). Although the central portion of the adobe is mostly deteriorated, a chimney located in the middle of the original section is still extant (Figure 14). Because most of the walls have collapsed, it is difficult to determine the fenestration pattern in this central section. A door was located near the chimney on the east façade, with another on the south end near the two-story building. Historic photographs and assessor records indicate the building had a porch spanning the section from the north addition to the two-story building added in the 1940s (Figure 15).

Figure 15. County Assessor Records, sketch of the adobe, 1952.

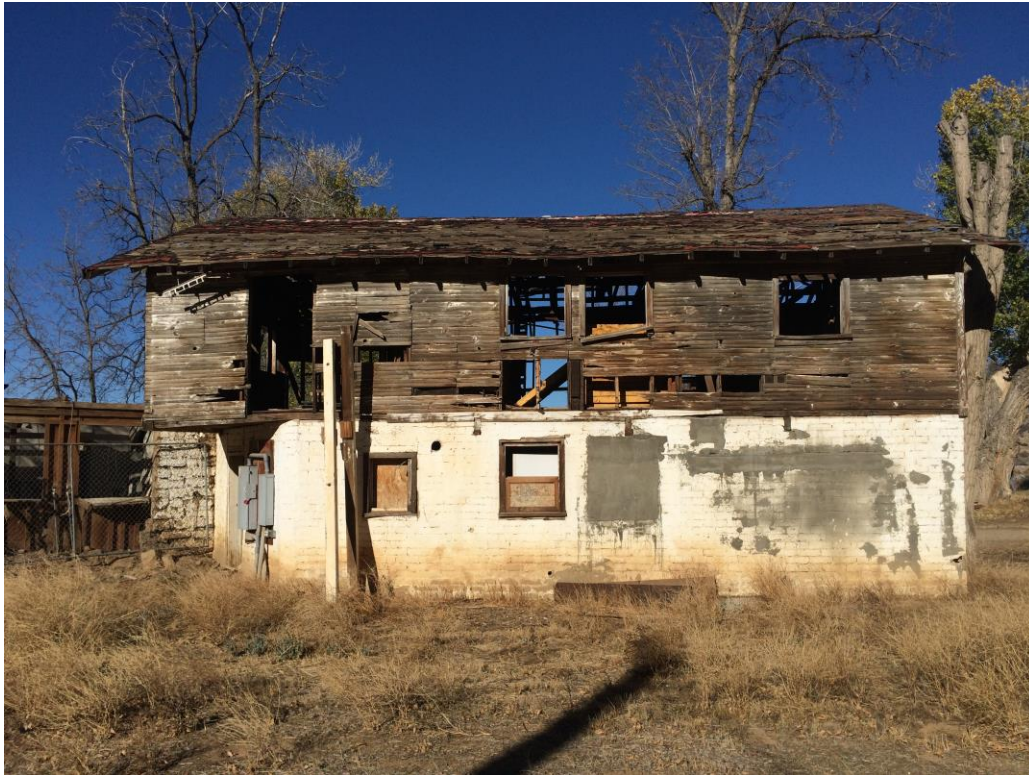
Figure 18. Overview of west façade of two-story addition, view towards the north.

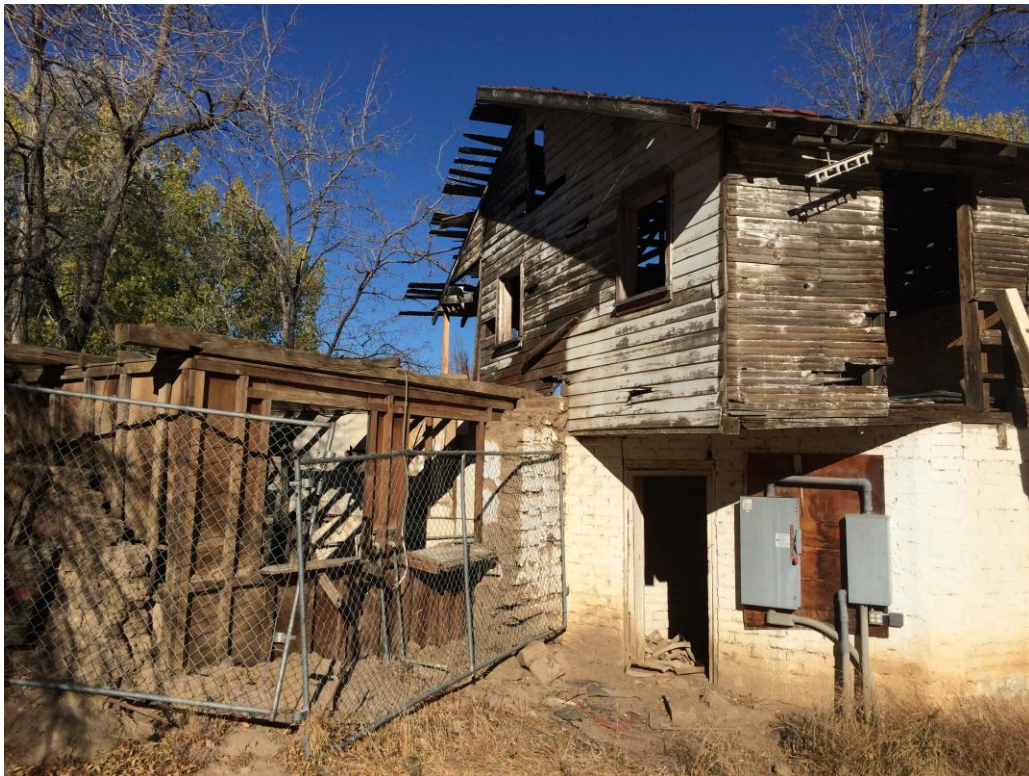
The south façade has a window matching those on the east façade at the east end of the first story, and a narrow window to the west which at one time contained glass block (Figure 17; see Figure 7). On the second story there were originally two square-shaped windows but only the openings remain. There was also a small window near the gable end. On the west façade, some openings have been covered with concrete, but there are still two openings on the north end of the first story (Figure 18). On the second story, the deteriorating clapboard makes the fenestration pattern unclear, but one frame is located near the south corner with two additional openings to the north. A portion of the second story overhangs the first at the northwest corner and there is a door located on the angled wall below near the junction with the one-story building. The second story of the north façade has two square openings with an additional window in the gable end (Figure 19).

Figure 19. Oblique view of south façade of two-story addition, view towards the northeast.
